**RHODE ISLAND DEPARTMENT OF TRANSPORTATION  
BRIDGE ENGINEERING-BRIDGE INSPECTION UNIT**

**BRIDGE CRITICAL FINDINGS  
(Form BI-006)**

<b>Bridge No.:</b>	070001
<b>Bridge Name:</b>	Washington Bridge North
<b>Route Carried:</b>	I-195 WB
<b>Crossing:</b>	Seekonk River
<b>City/Town:</b>	East Providence

**Date Reported:**  
12/11/2023  
**Time Reported:**  
11:30  
**Reported By:**  
Jeff Klein  
**Firm/Agency:**  
VHB

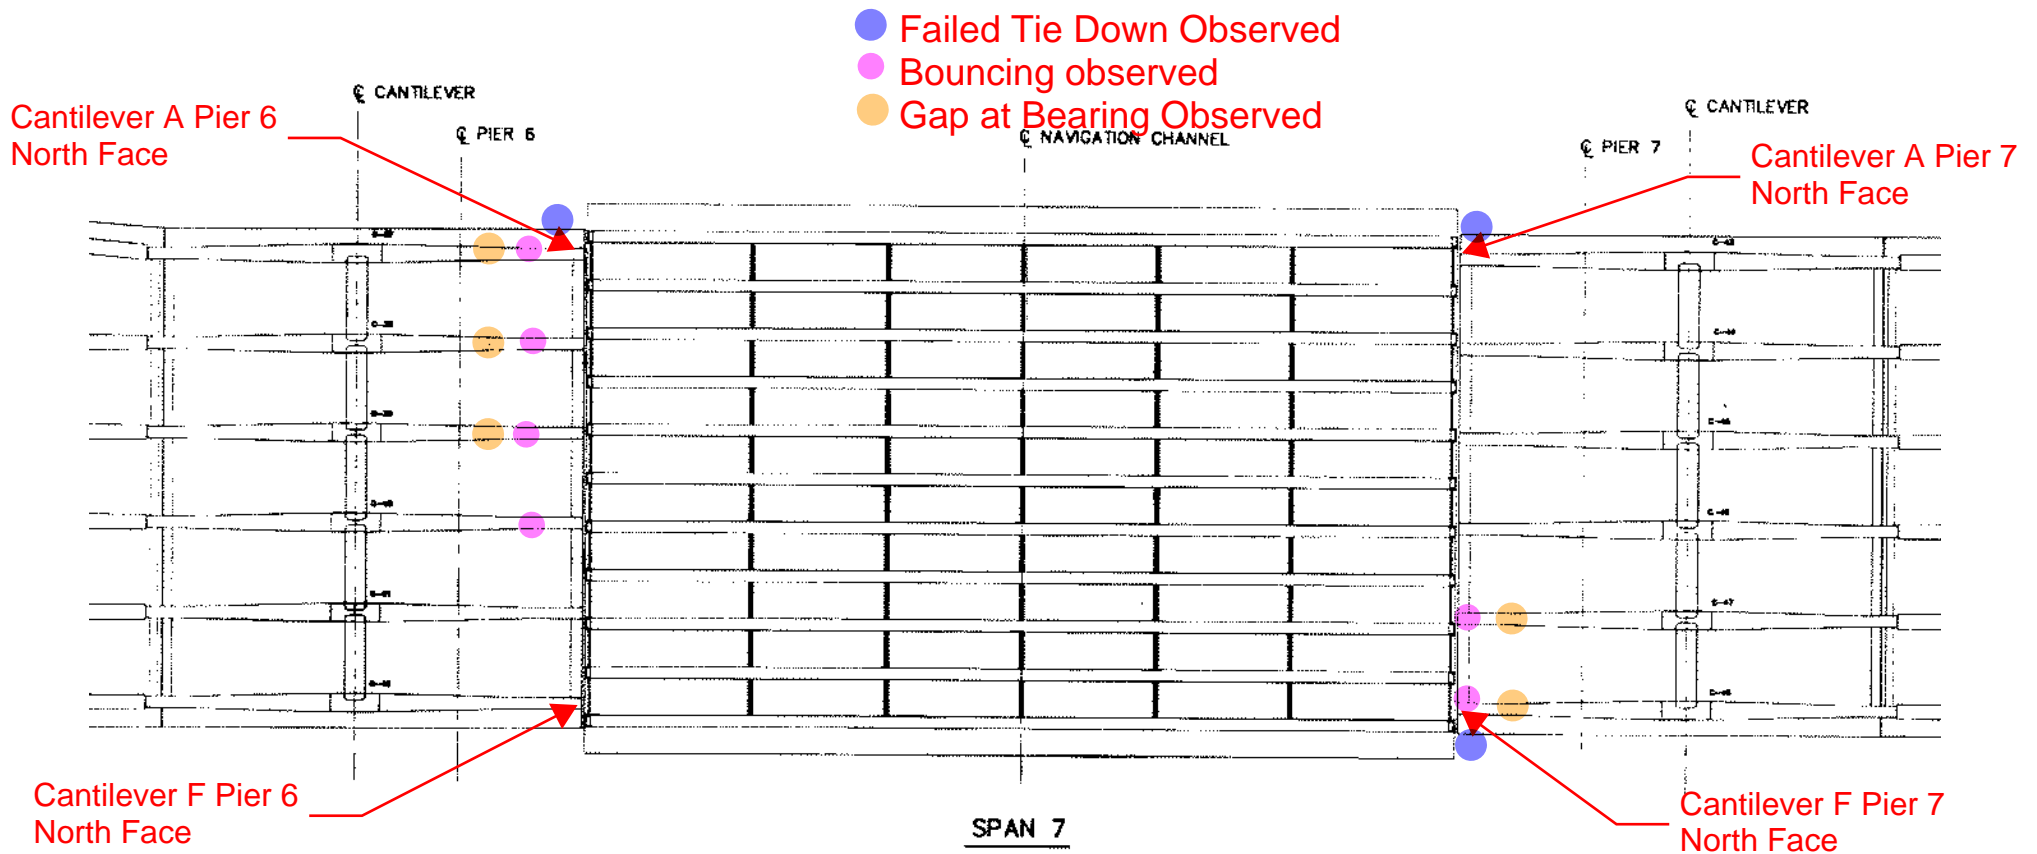
At Piers 6 and 7 there are 12 post tensioned rods (tiedowns) per pier that are securing the cantilever concrete spans. There are 2 rods per pier at the fascias that are fully exposed as part of the original construction of the bridge.

West Wall of Pier 7 – The post tensioned rods located north and south of cantilever beam F are severed.

East Wall of Pier 6 – The post tensioned rods located north and south of cantilever beam A show necking with up to 1” remaining diameter (1.375” original diameter). At Girder A, a gap was found between the cantilever end and beam seat, and bouncing of the cantilever end and tiedown was observed. Based on these observations it is assumed that the tiedown has failed with the failure location not visible.

Notified RIDOT. Bridge closure recommended.

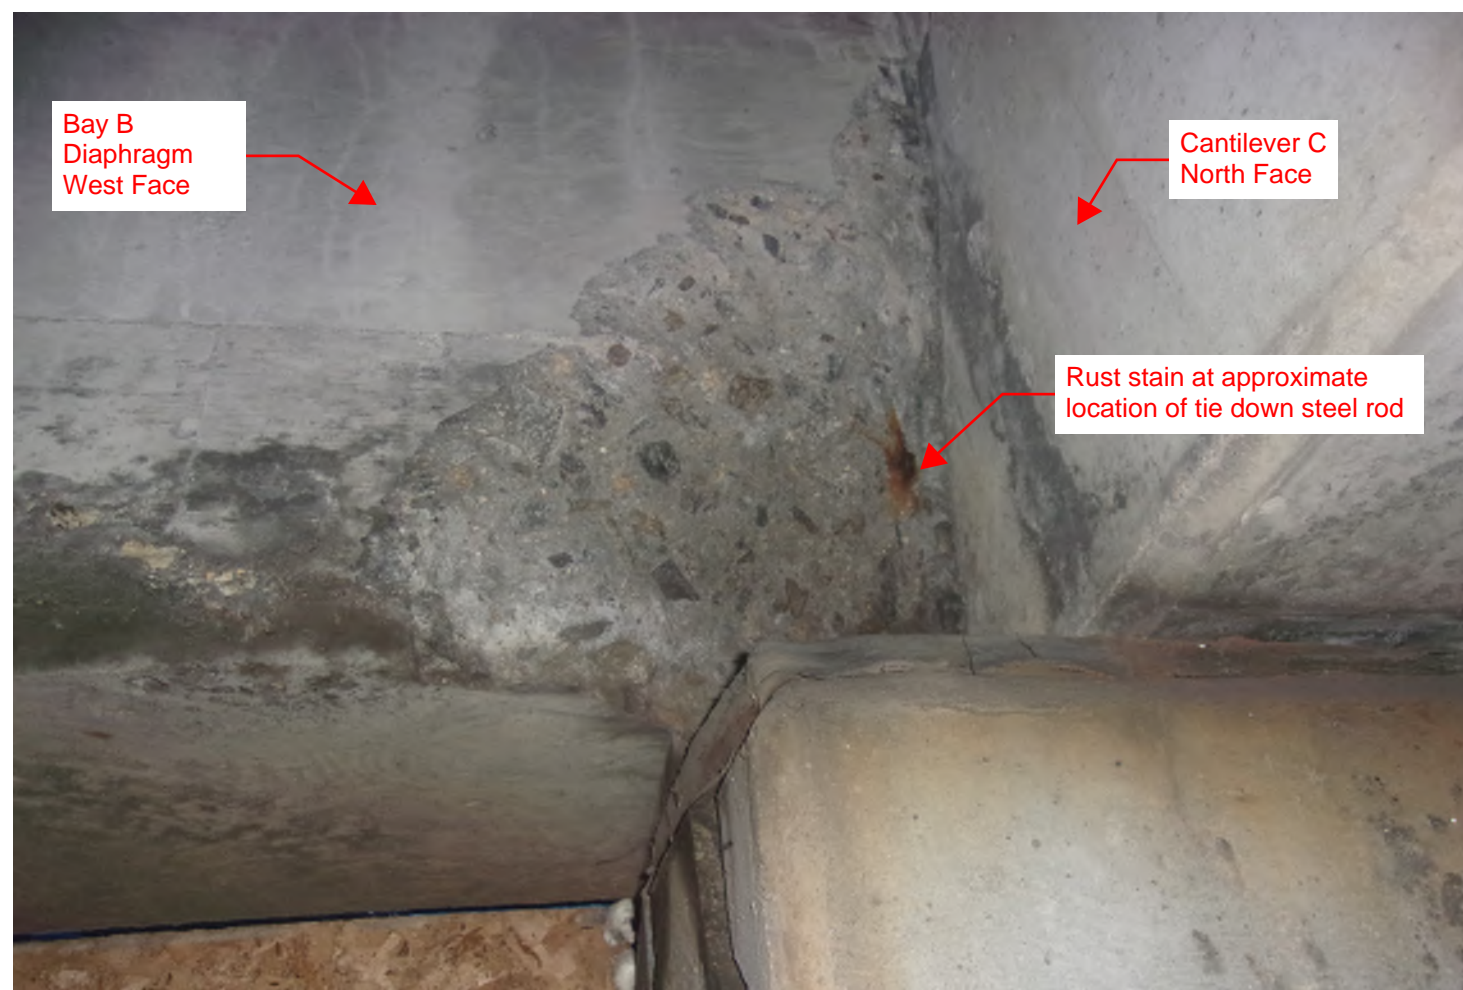
Cantilever C North Face

- Spalls on diaphragm at Cantilever C north and south face. Rust stain on the Bay B diaphragm at approximate tie down steel rod location, and exposed steel rod at Bay diaphragm.

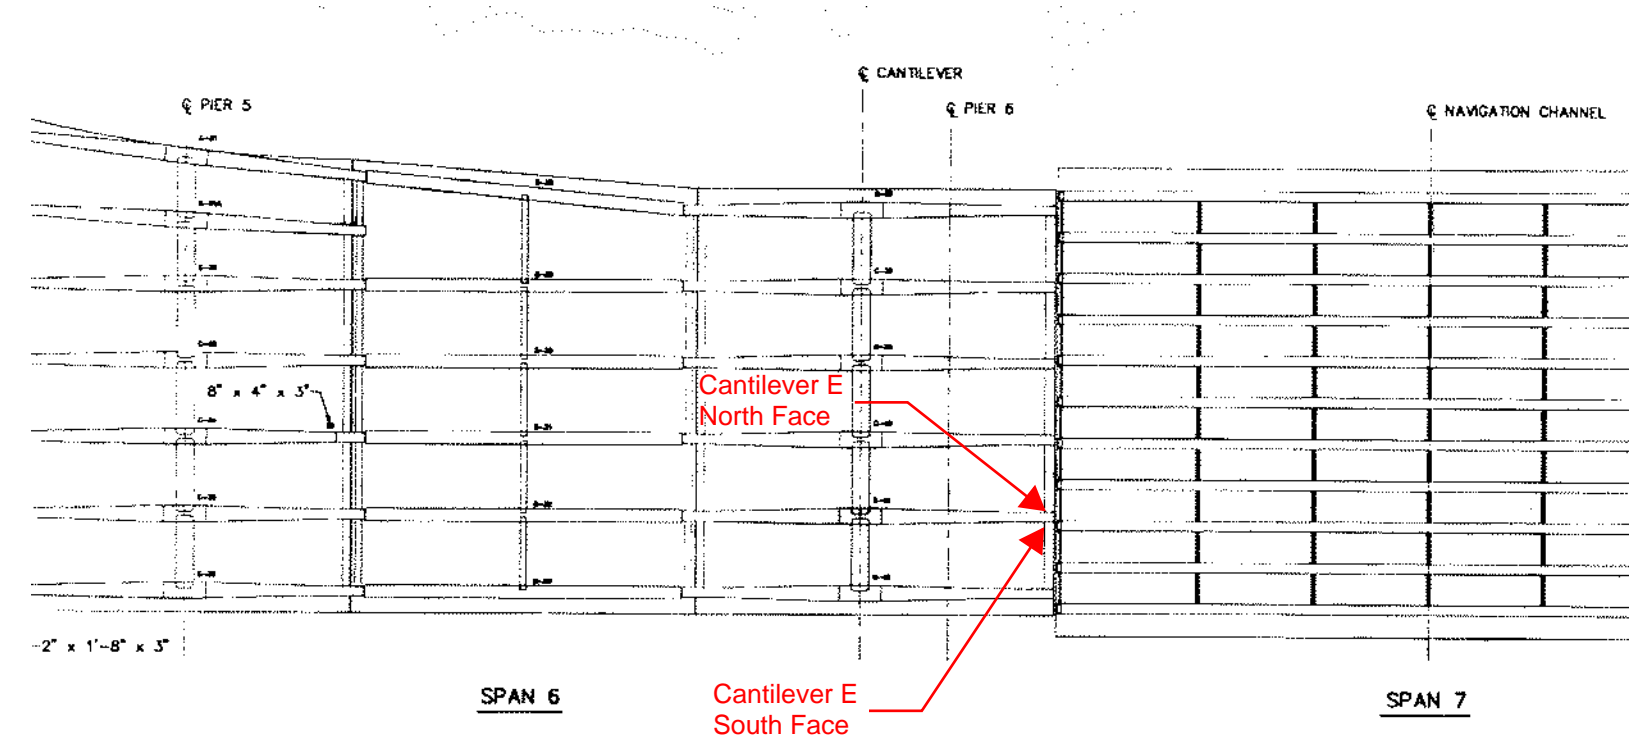
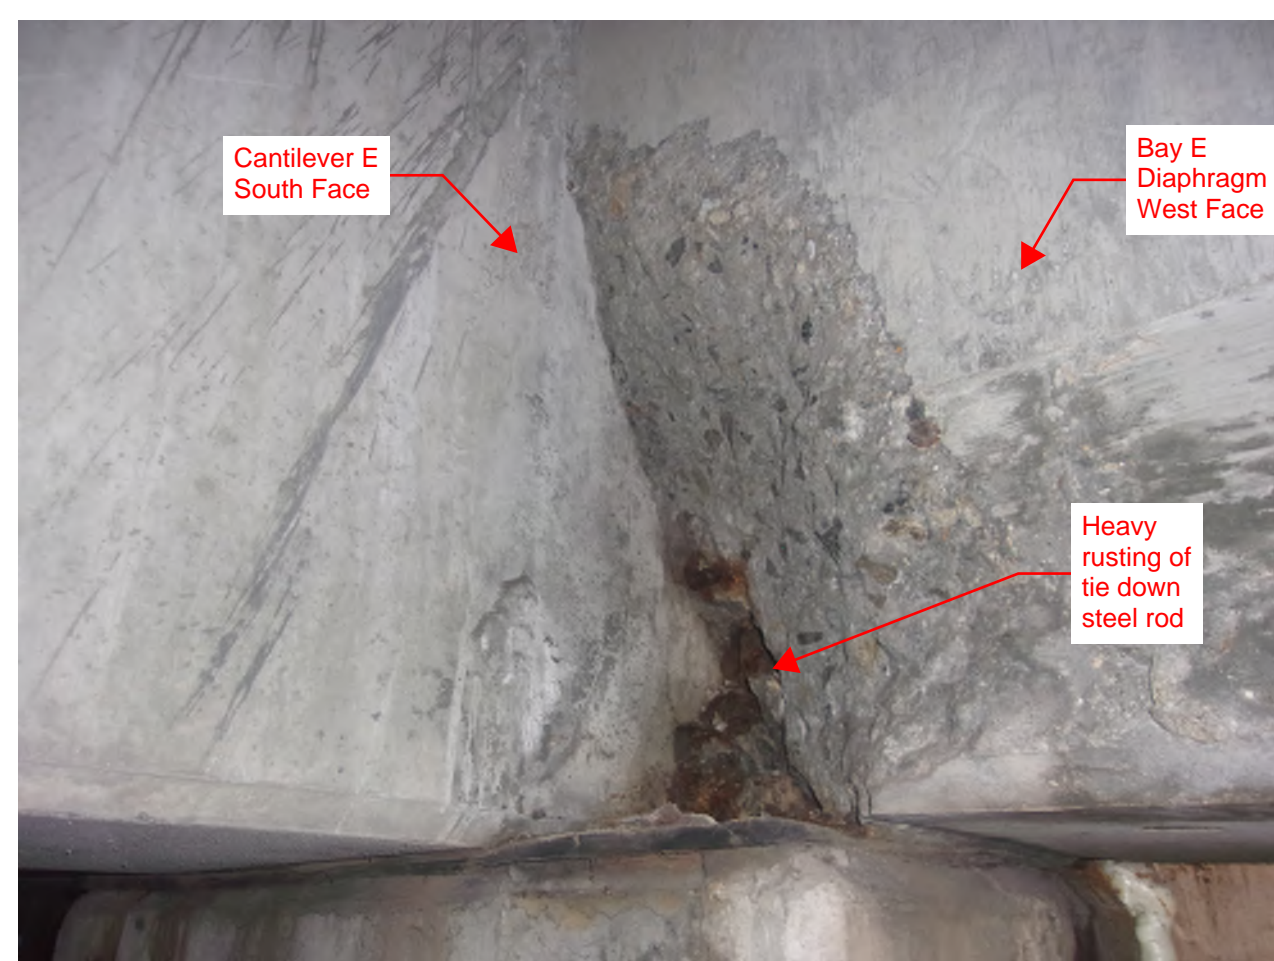
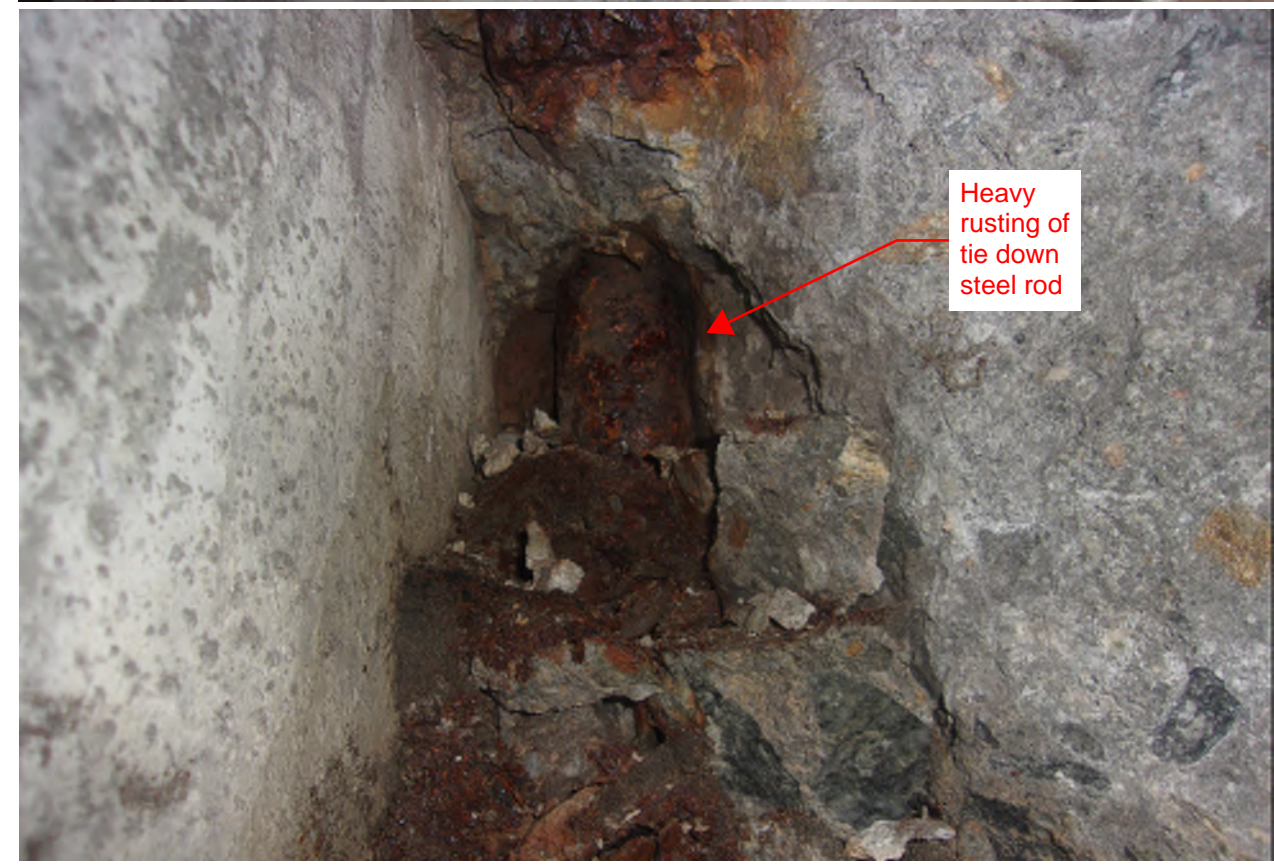
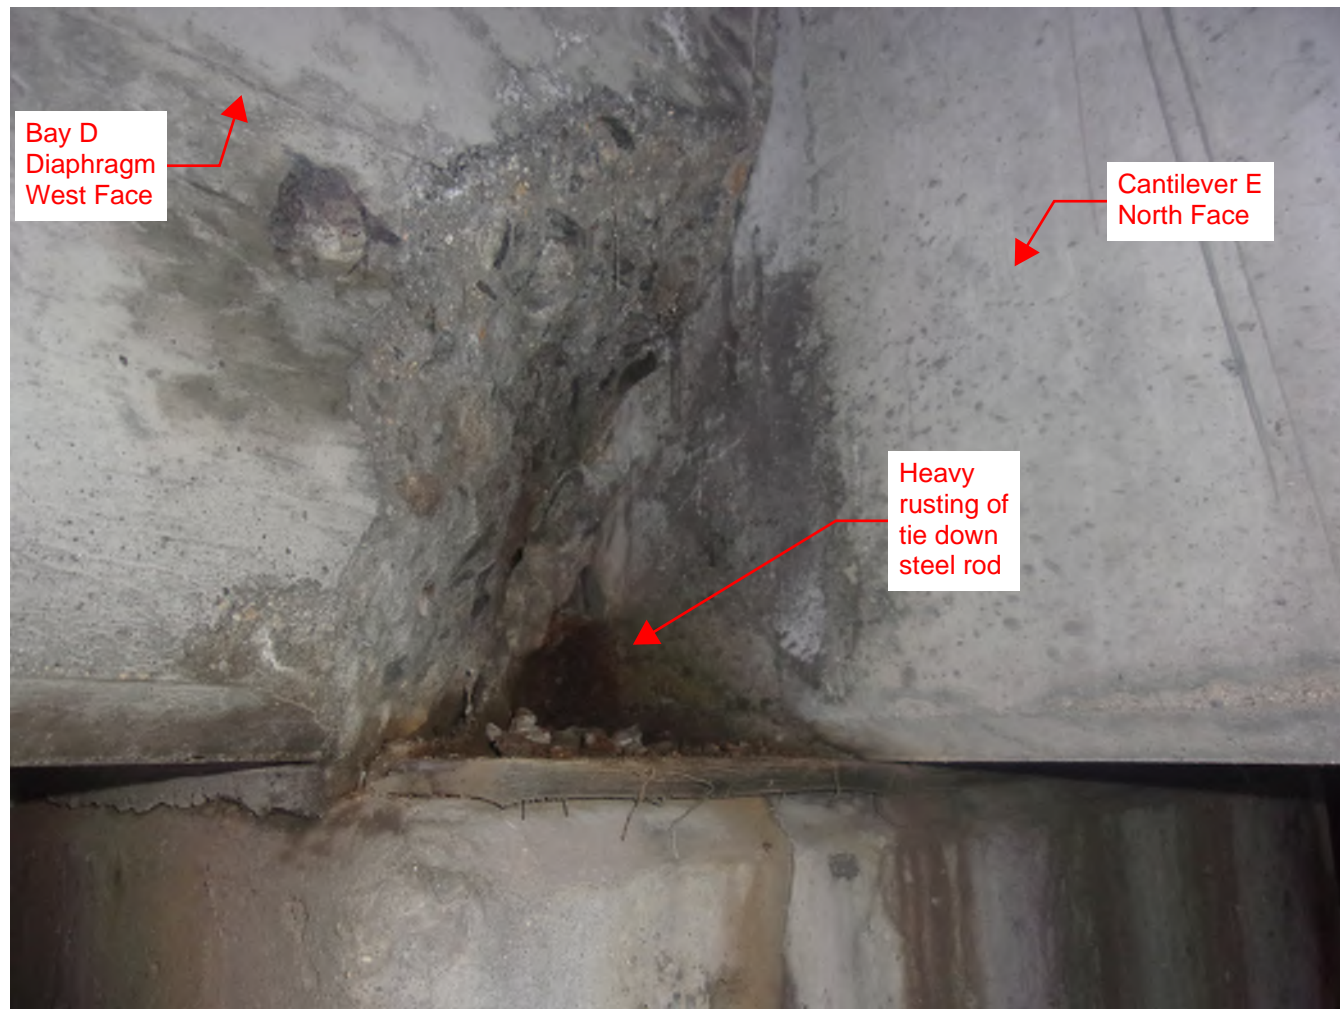
Cantilever E North Face

Cantilever E South Face

Note:  
 - Spalls on diaphragm at Cantilever E north and south face. Tie down steel rod exposed with heavy rusting.

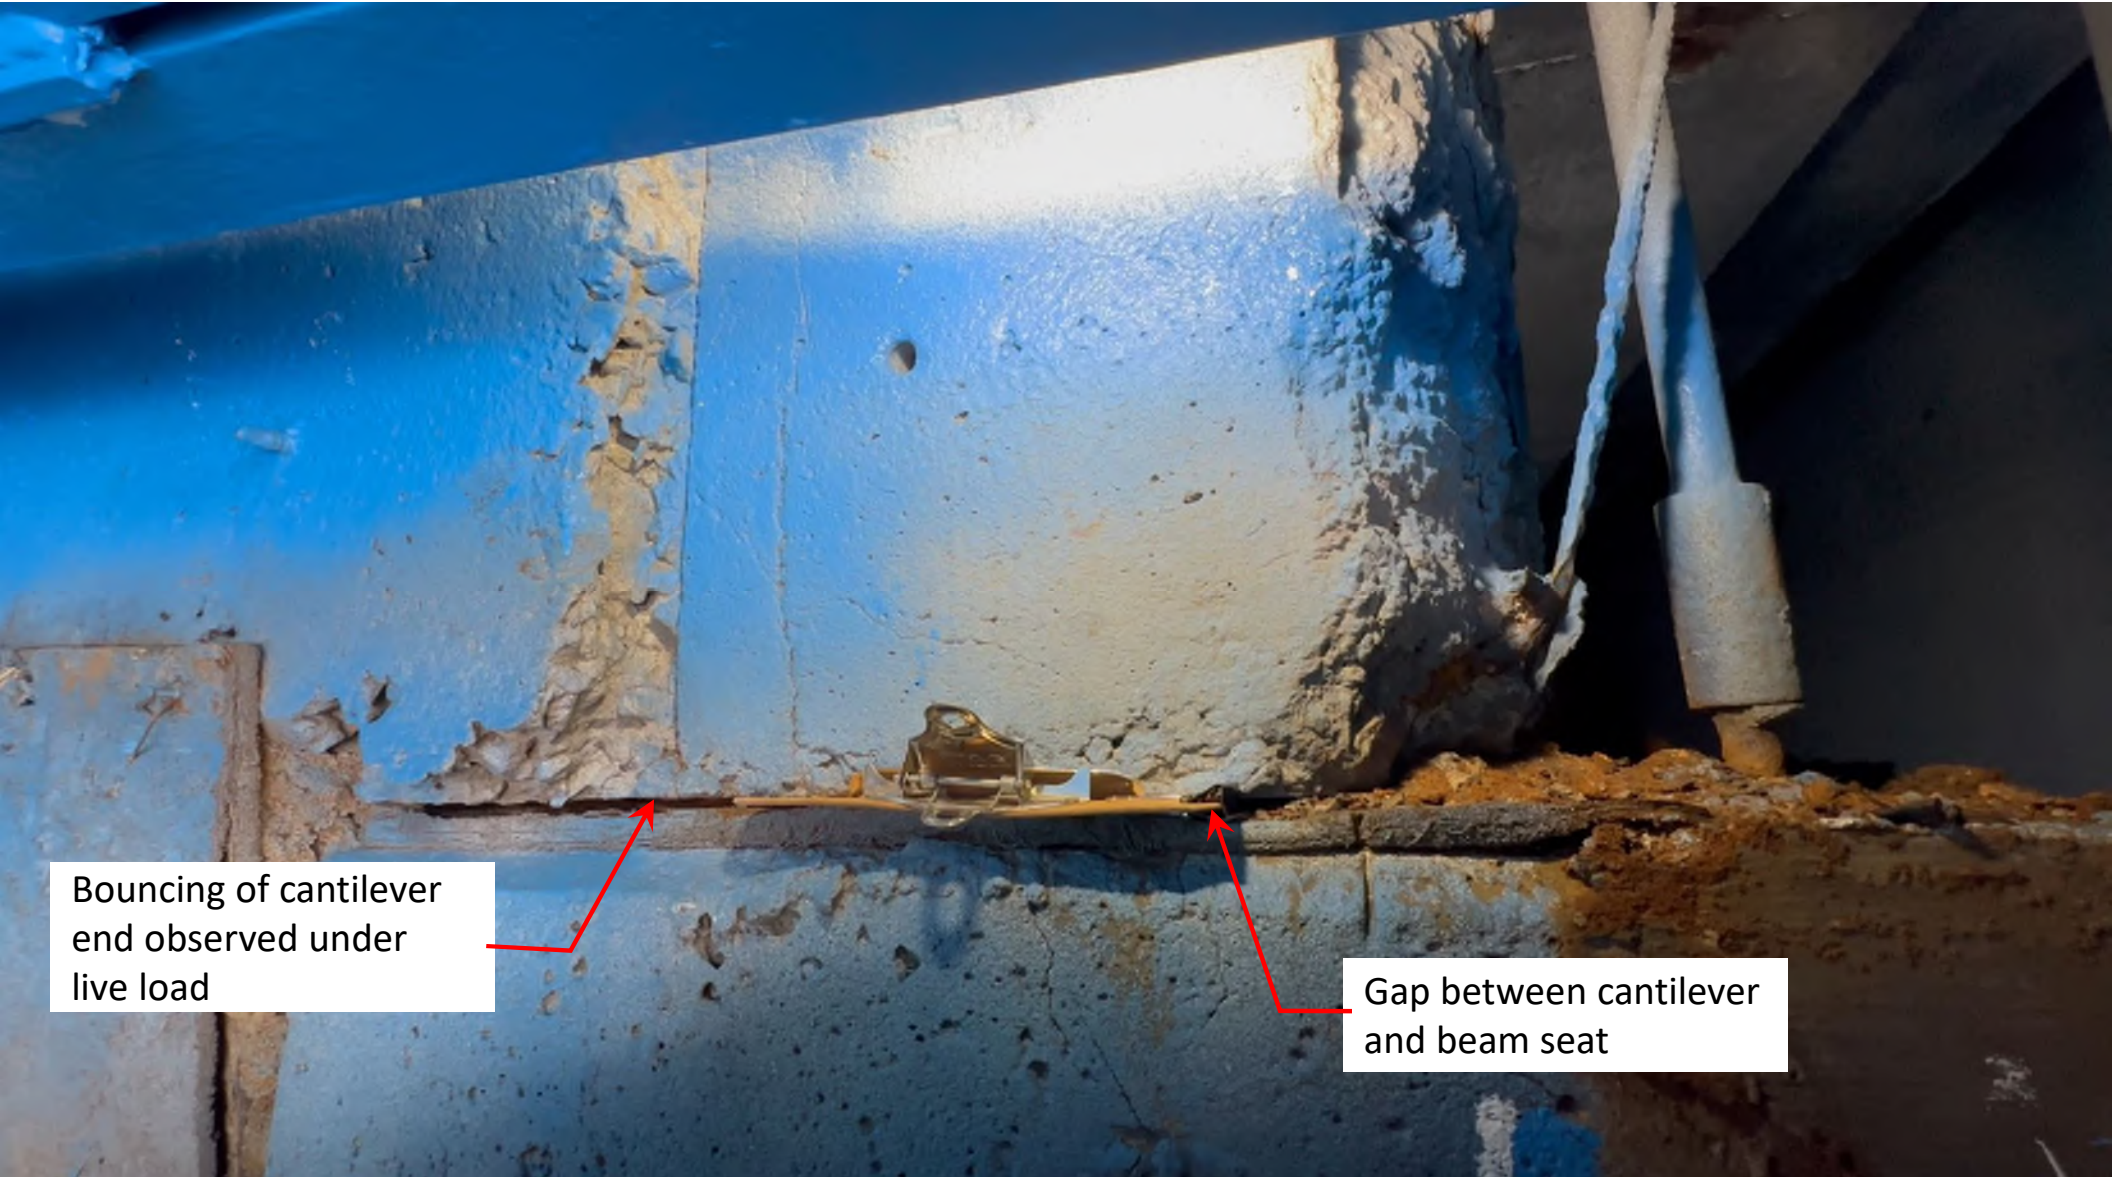
Photo #2

- See photos 1 and 2.
- 1" diameter remaining at base of steel rod (original 1 3/8" diameter based on 1967 record plans) (See Photo 1).
- Defect to cause failure of tiedown not found, however, it was observed a gap between cantilever end and beam seat (fit 11" long section of clipboard in gap), bouncing of cantilever end and tiedown under live load. It is assumed based on the observations that the tiedown has failed with the failure location not visible. (See Photos 1 and 2)

Bouncing of cantilever end observed under live load

Gap between cantilever and beam seat

Cantilever A East Face at Pier 6  
(Looking West)

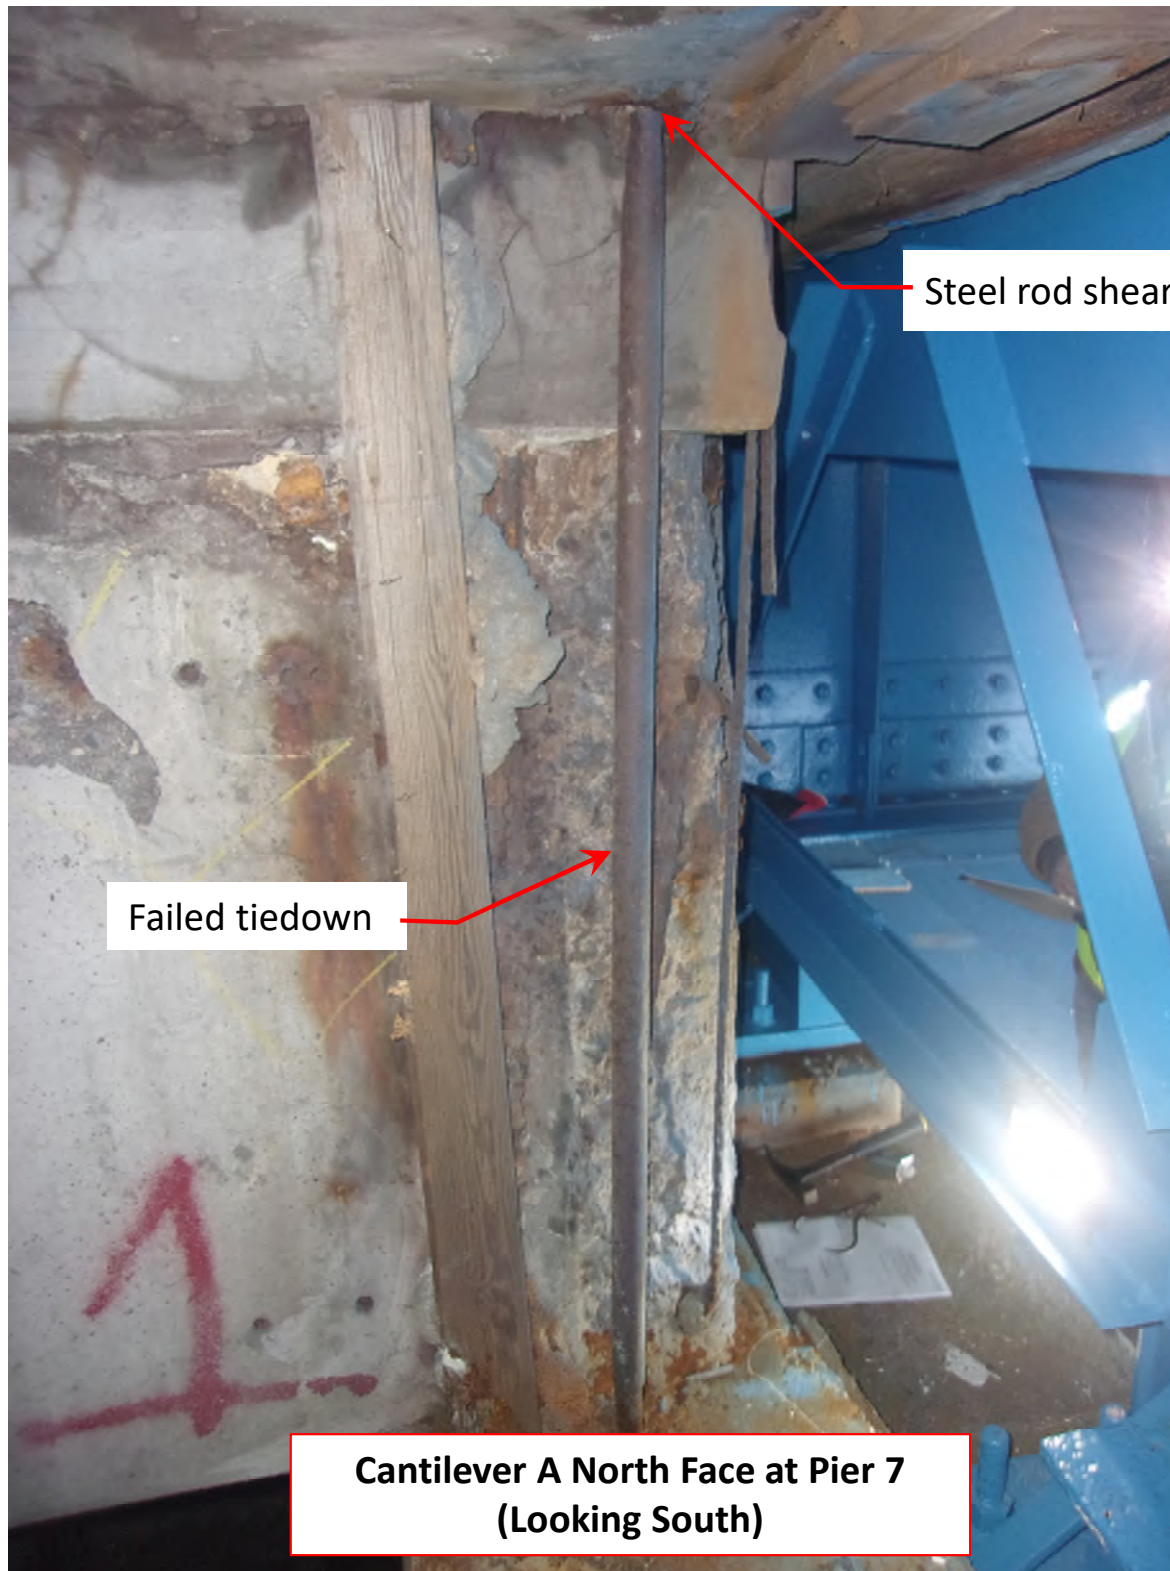
Photo #3

- See photos 3-5.
- Tiedown steel rod failed, sheared at the top below deck (See Photos 3-5)

Steel rod sheared at top

Failed tiedown

Cantilever A North Face at Pier 7  
(Looking South)

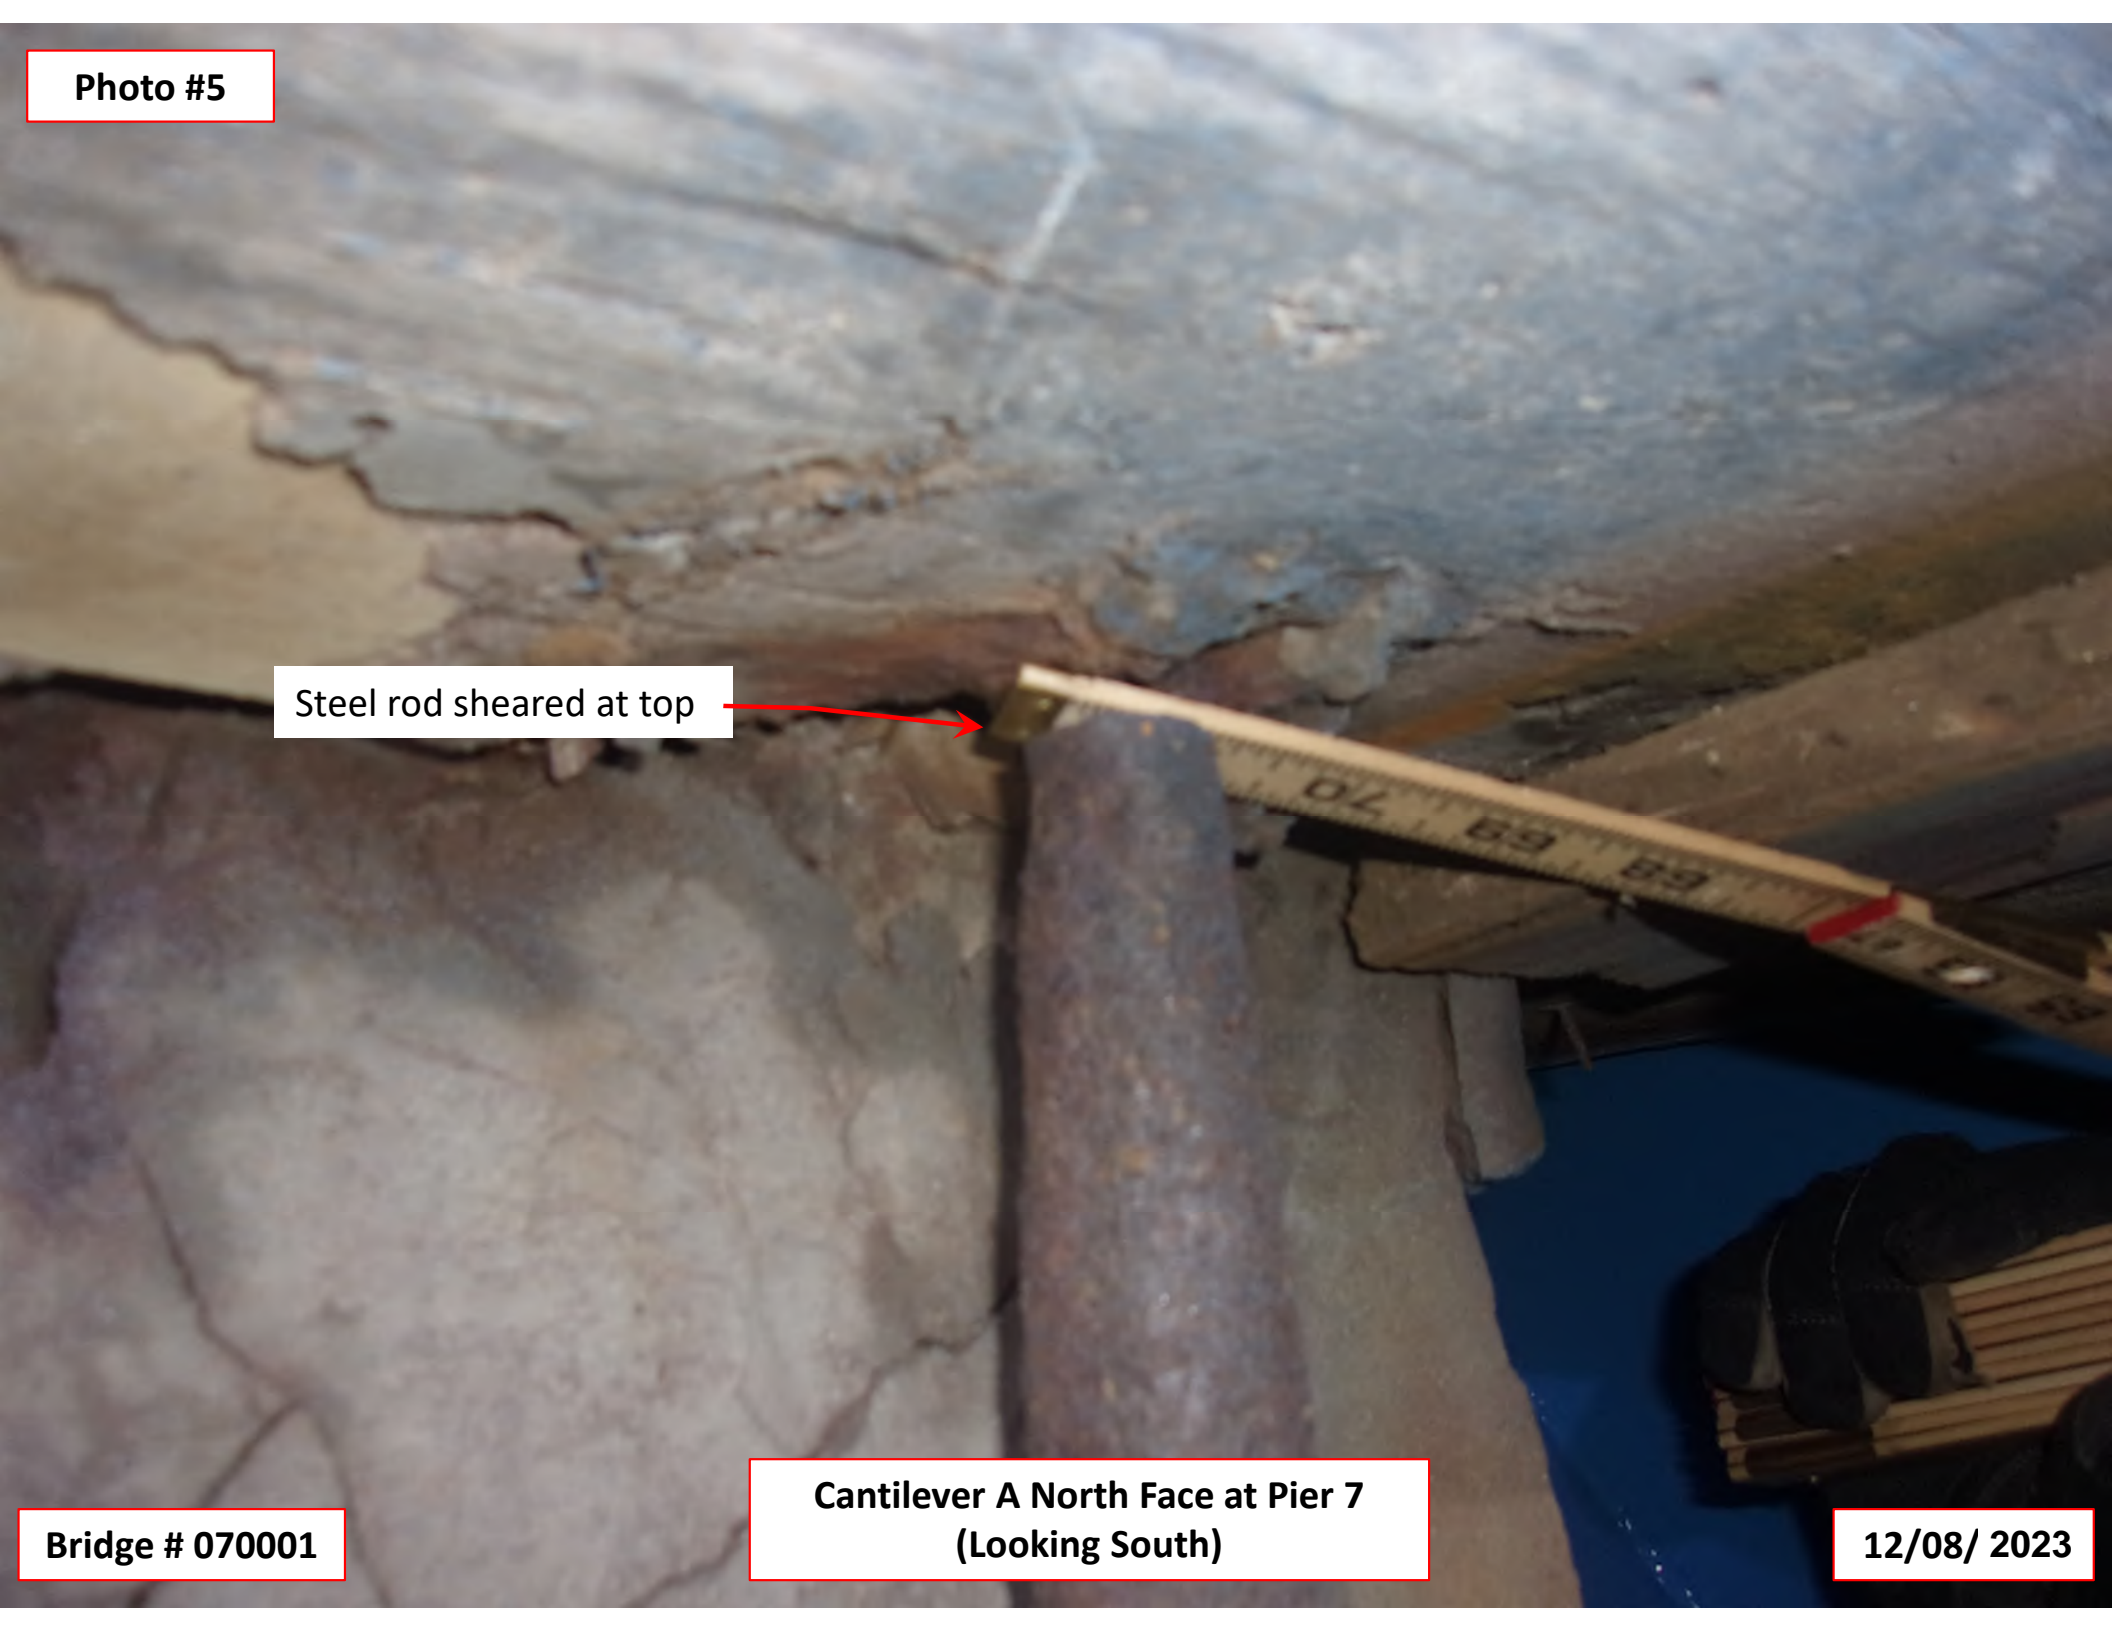
Photo #5

Steel rod sheared at top

Cantilever A North Face at Pier 7  
(Looking South)

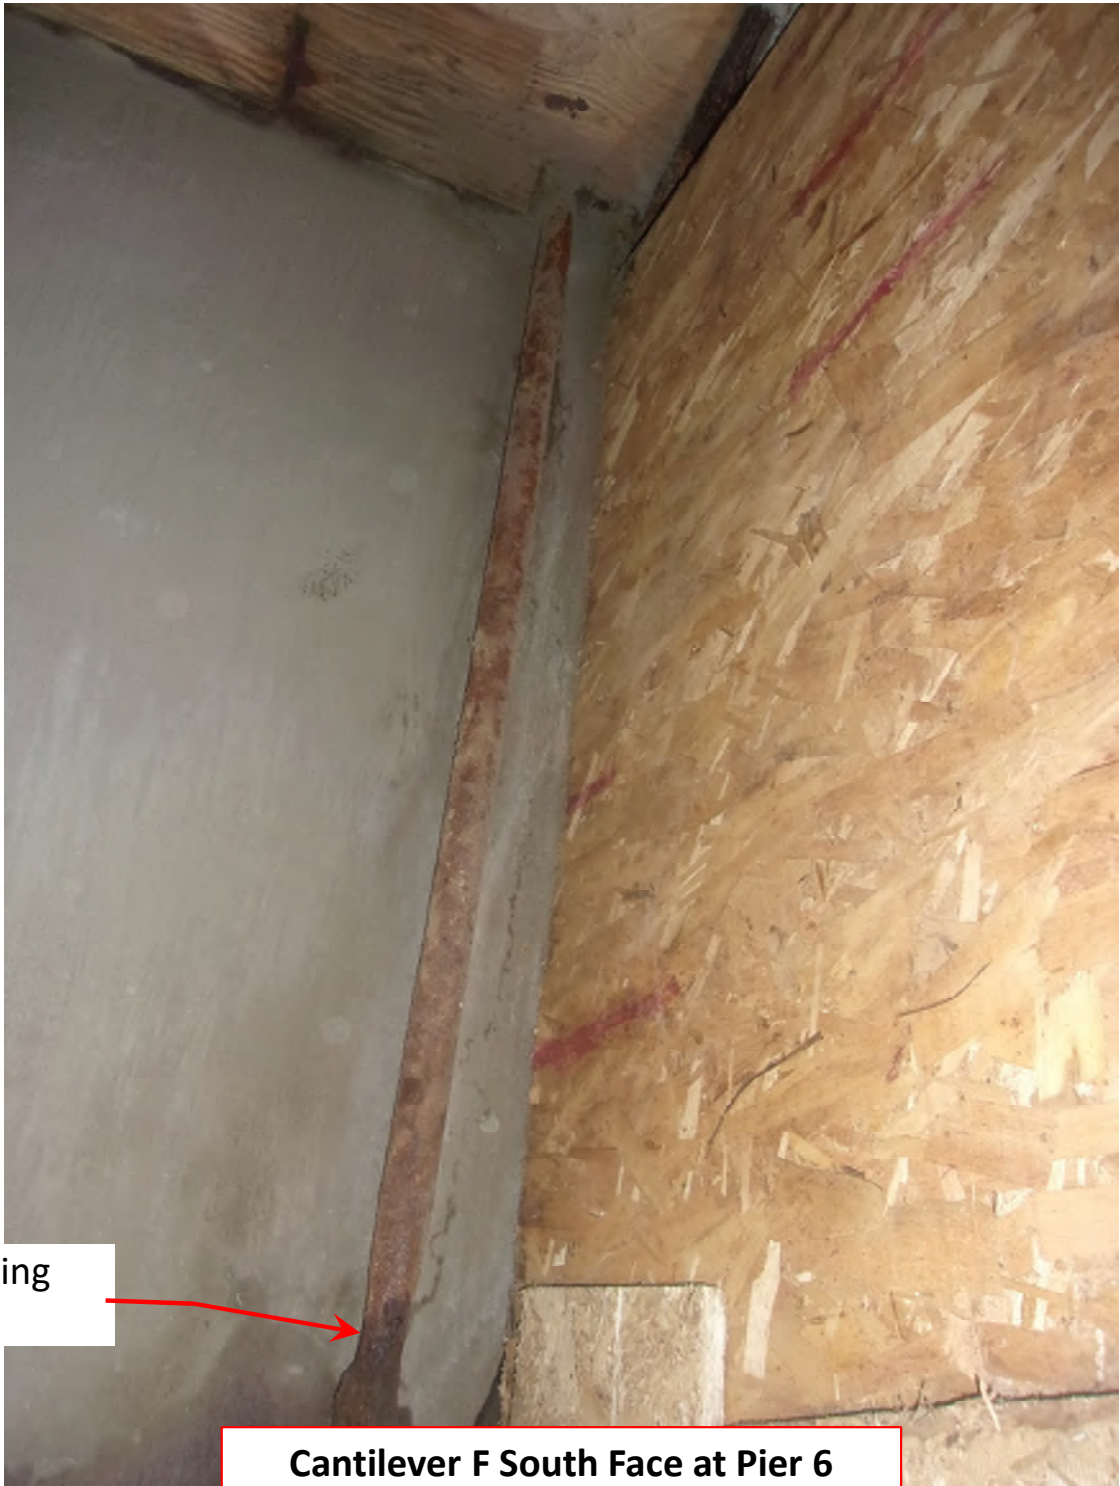
**Photo #7**

- See photos 6 and 7.
- 1" diameter remaining at base of steel rod (original 1 3/8" diameter based on 1967 record plans) (See Photos 6 and 7).

1" diameter remaining  
near base

**Cantilever F South Face at Pier 6  
(Looking North)**
