## **Forensic Investigation of Failed Post-Tensioned Tie-Down Rods I-195 SB Washington Bridge North (700)**

**Evaluation of I-195 Washington Bridge PT Bar Fractures**  
 WJE No. 2023.7858.0

**Metallurgical Evaluation**

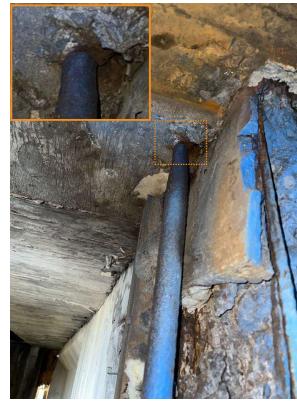
Photos of the fractured bars taken by WJE on December 16, 2023 are shown in Figures 2 and 3. The bars were corroded on the exterior perimeter and the cross-section was reduced/tapered in the regions around the fractures. According to original design drawings, the prestressing rods were to be 1 3/8" diameter threaded high strength pre-stressing rod to be tensioned to 120,000 lbs. each (Figures 4 and 5). No specification is cited for high-strength rod and original project specifications were not provided. As a basis for comparison, Table 1 shows relative stresses based on section loss and applied post-tension load only. The applicable design specification would have limited post-tension load before losses to 0.7  $f_s$ .<sup>2</sup>

Figure 2. Pier 7 Cantilever A fractured tie-down rod

- At the locations of fracture, bar section had been reduced to 0.98 to 1.006 inch in diameter and 0.882 to 0.925 inch in diameter for Cantilever A and Cantilever F rods, respectively. From a nominal design diameter of 1.375 inch, this represents losses of 48% and 57%, respectively, of the original cross-sectional area.

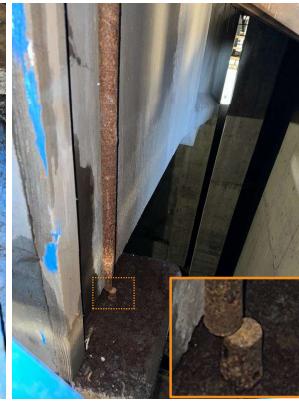
Figure 3. Pier 7 Cantilever F fractured tie-down rod

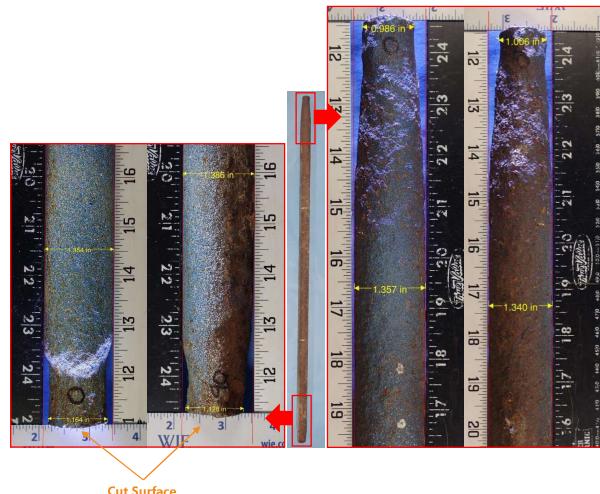
The received bars were approximately 4 feet (Cantilever A) and 2 feet 5 inches (Cantilever F) in length (Figure 1). The surfaces of both bars were reddish-brown and uniformly rusted. Each end of Cantilever A appeared tapered, one side to a cut surface and the other side to a fracture face. The reduction in diameter was measured on each side and is shown in Figure 2. Two diameter measurements were made 90 degrees apart on each side. The two orthogonal diameter measurements adjacent to the fracture face were 0.986 inch and 1.006 inch, while similar measurements away from the fracture face were 1.357 inch and 1.340 inch. Cantilever F also exhibited a tapered end at the fracture face. Similarly, two diameter measurements were made 90° apart adjacent to the fracture and away from the fracture (Figure 3). The diameter measurements adjacent to the fracture were 0.925 inch and 0.882 inch, and the diameter away from the fracture was 1.298 inch and 1.270 inch.

Figure 2. Cantilever A diameter measurements mapped to location on PT bar.

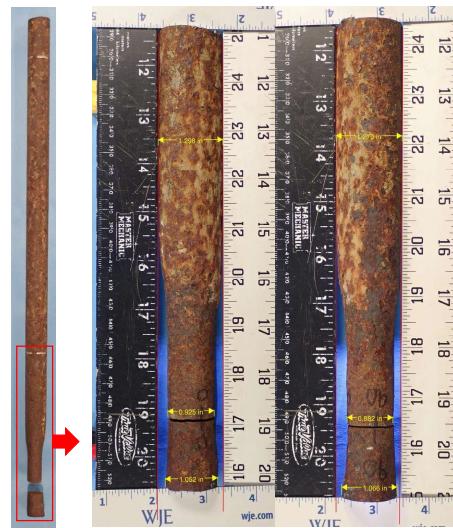
Figure 3. Cantilever F diameter measurements mapped to location on PT bar.

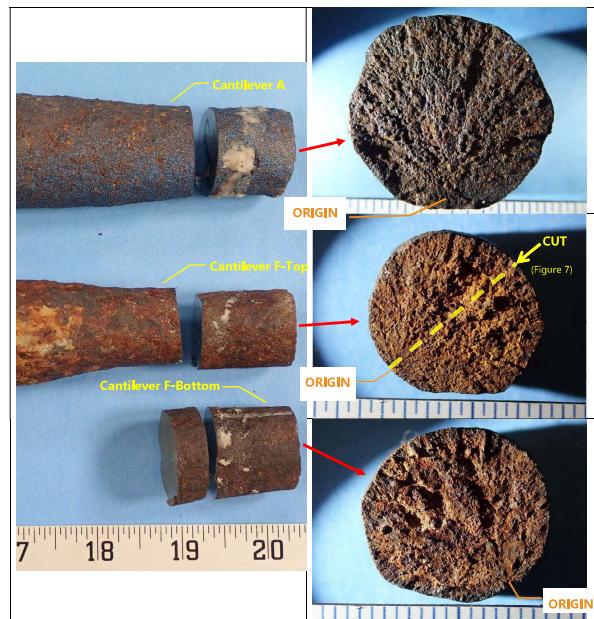
The fractured ends were sectioned from the bars for closer visual examination (Figure 4). All three fracture faces were heavily corroded, with no discernible features other than the general location of the fracture origin and the direction of fracture propagation. After chemically removing the rust from the Cantilever A fracture face, examination with the aid of a stereo zoom microscope indicated that the microtopography had been badly degraded by corrosion. Nevertheless, the macroscopic features were consistent with sudden, rapid fracture preceded by negligible plastic deformation.

Figure 4. Fracture faces of each PT bar with labeled origin and side lighting. Note the Cantilever A fracture face has blue paint specks across the fracture face.

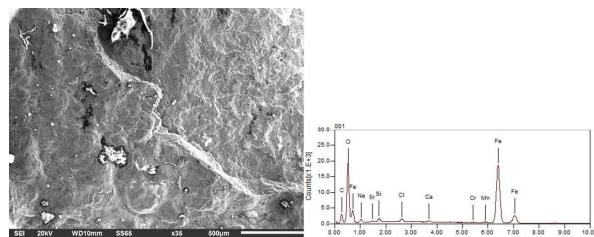
characteristic x-ray energy peaks whose relative heights provide a semi-quantitative analysis of the composition. The following elements were identified in each sample: oxygen (O), bromine (Br), silicon (Si), chlorine (Cl), calcium (Ca), iron (Fe), and trace amounts of zinc (Zn), phosphorus (P), sulfur (S), potassium (K), chromium (Cr), and manganese (Mn). Table 1 summarizes the samples examined and the chemical species identified. SEM images and their respective EDS spectra are shown in Figure 5 and Figure 6.

Figure 5. SEM image and corresponding EDS spectrum of Cantilever A fracture face origin and identified elements present.

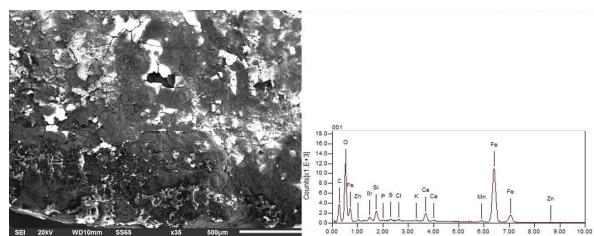
Figure 6. SEM image and corresponding EDS spectrum of Cantilever F-Bottom fracture face origin and identified elements present.

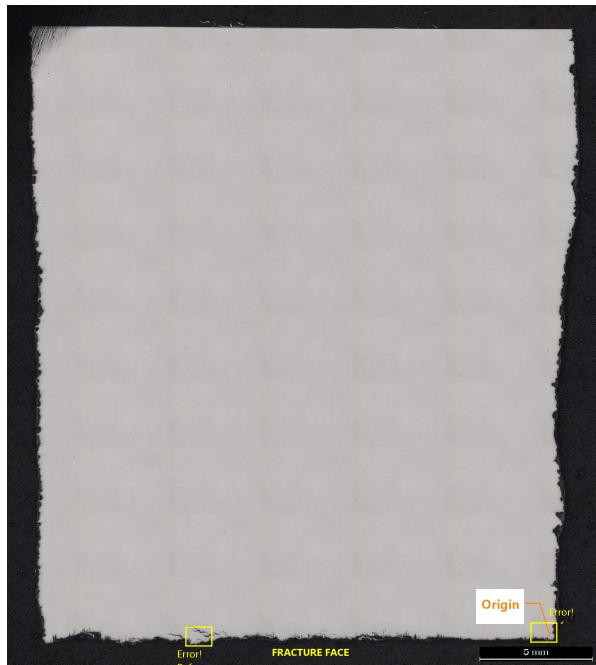
One longitudinal diametral section bisecting the fracture origin was taken through the fracture face of Cantilever F-Top, as indicated by the dashed yellow line in Figure 4, and prepared for metallographic observation. A metallographic montage of the entire unetched section is shown in Figure 7. Figure 8

Figure 7. Cantilever F-Top: metallurgical montage of an unetched diametral section through the fracture face and bisecting the fracture origin, as noted in Figure 4.

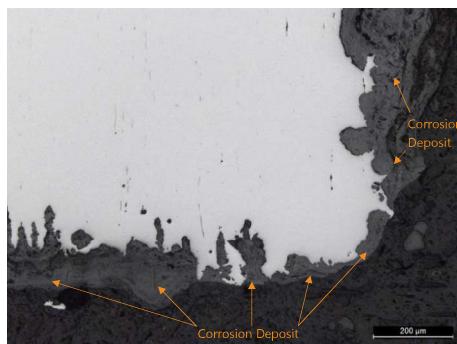
shows the origin location and associated corrosion products, and Figure 9 shows extensive subsurface secondary cracking approximately two-thirds of the diameter away. Figure 10 shows another metallographic montage across the diameter of the fracture face, with rust thickness measurements along the sides of the bar and the fracture face. The average rust thickness along the fracture face was calculated as 0.085 mm (2.56 mil) and along the sides of the bar was calculated as 0.153 mm (6.02 mil).

Figure 8. Cantilever F-Top higher magnification image at the origin location.

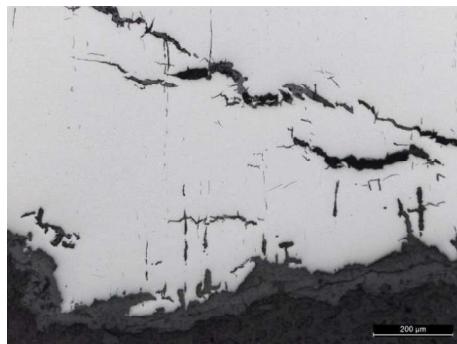
Figure 9. Cantilever F-Top higher magnification image of subsurface secondary cracking near the fracture face.

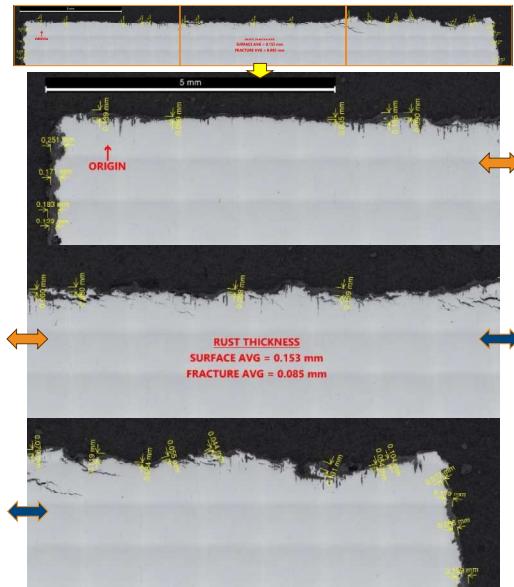
Based on rust layer thickness on the fracture faces, it is highly likely that the fractures occurred prior to the most recent bridge inspection six months ago. In the reduced sections where fracture occurred, the absence of observable plastic flow in the pearlitic steel microstructure suggests that the loss of section was primarily due to corrosion rather than pre-fracture tensile necking. The sodium (Na), calcium (Ca), chlorine (Cl), and bromine (Br) detected in the corrosion products suggest the presence of sodium and calcium chloride salts (with bromide impurities) commonly used in roadway deicing. However, the strength of the bromine peaks in the EDS spectra indicate that the primary source of the salt deposits may have been sea spray, since the ratio of bromide ions to chloride ions is more than an order of magnitude higher in seawater than in solutions of deicing salts. In the present case it would be reasonable to conclude that both sea spray and deicing salts were involved. More importantly, salt-bearing moisture from any source is well known to accelerate the aqueous corrosion of steel.

Figure 10. Cantilever F-Top metallurgical montage cropped into three segments to show corrosion product buildup across fracture diameter, annotated with rust deposit thickness measurements

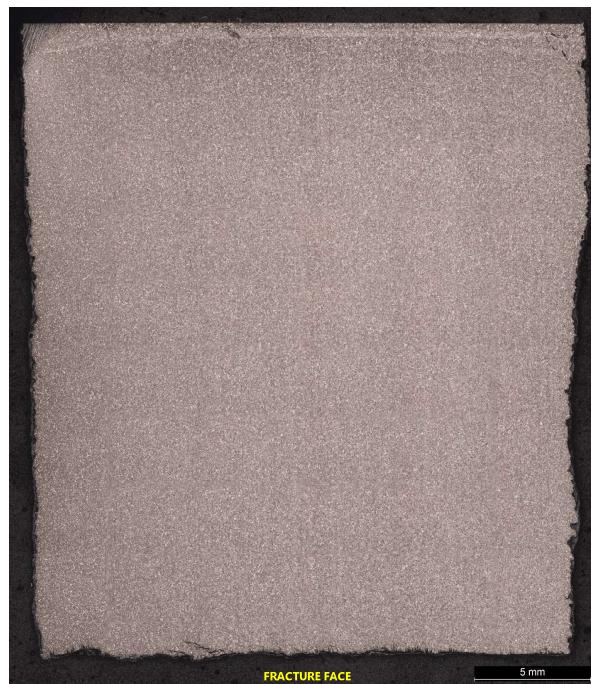
The polished section was etched with 2% nital to reveal the microstructure of the PT bar, which was found to consist of fully pearlitic, equiaxed grains throughout, and was consistent with the chemical composition of the steel. A metallographic montage in Figure 11 shows the entire section in the etched condition. No macro- or microstructural evidence of tensile plastic flow was observed anywhere in the section. More highly magnified images show the pearlitic structure and corrosion at the origin (Figure 12), and subsurface secondary cracking approximately two-thirds of the diameter away (Figure 13). For purposes of comparison with Figure 11, Figure 14 shows an example of metallographic evidence, in an unrelated case, of pre-fracture tensile plasticity.

Figure 11. Cantilever F-Top: metallurgical montage of the same section as shown in Figure 7, etched with 2% nital to reveal grain structure. Note the absence of tensile plastic flow in the microstructure, consistent with brittle fracture following negligible pre-fracture deformation.

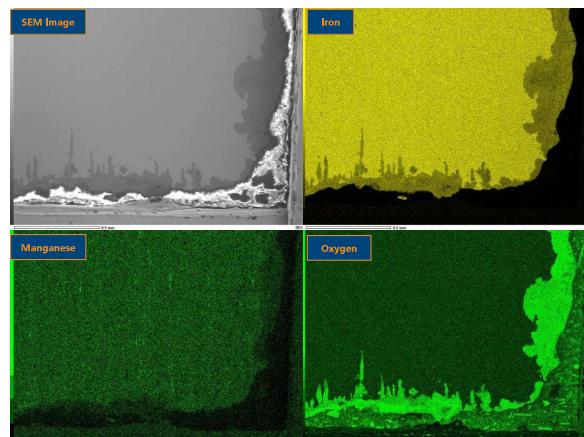
The polished section was also analyzed by EDS to characterize the elemental makeup of the corrosion along the fracture face. An elemental map at the origin is displayed in Figure 15, showing the makeup of the corrosion to be primarily oxygen and iron (rust). Some manganese sulfide inclusions were also picked up by the mapping. An elemental map was also made at the subsurface secondary cracking adjacent to the fracture (Figure 16). Similarly, the corrosion along the fracture face primarily consists of oxygen and iron. Oxygen and iron were also the primary makeup of the observed secondary cracking. Bromine was also observed in the secondary cracks and in the fracture face deposit.

Figure 15. SEM image and EDS elemental mapping at the fracture origin of the mounted sample of Cantilever F-Top.

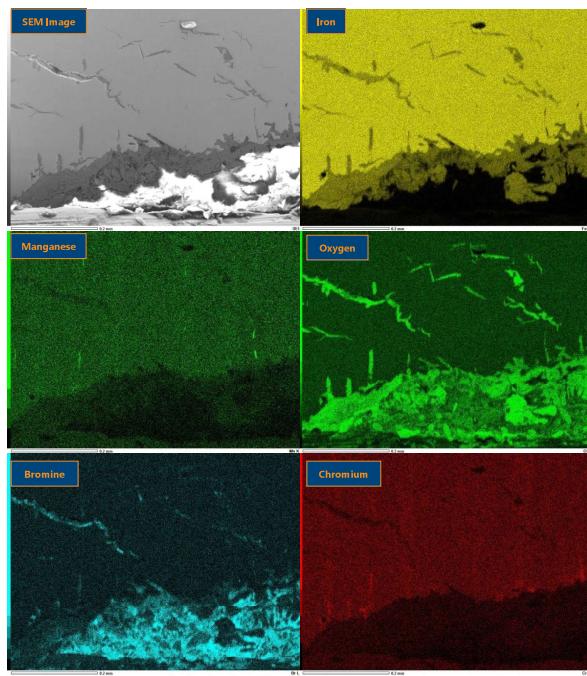
Figure 16. SEM image and EDS elemental mapping at the fissuring at the fracture face of Cantilever F-Top.
