Washington Bridge Update

**House Committee on
Oversight &
Senate Committee on Rules,
Government Ethics &
Oversight**

February 12, 2024

Evaluation and Repair Timeline

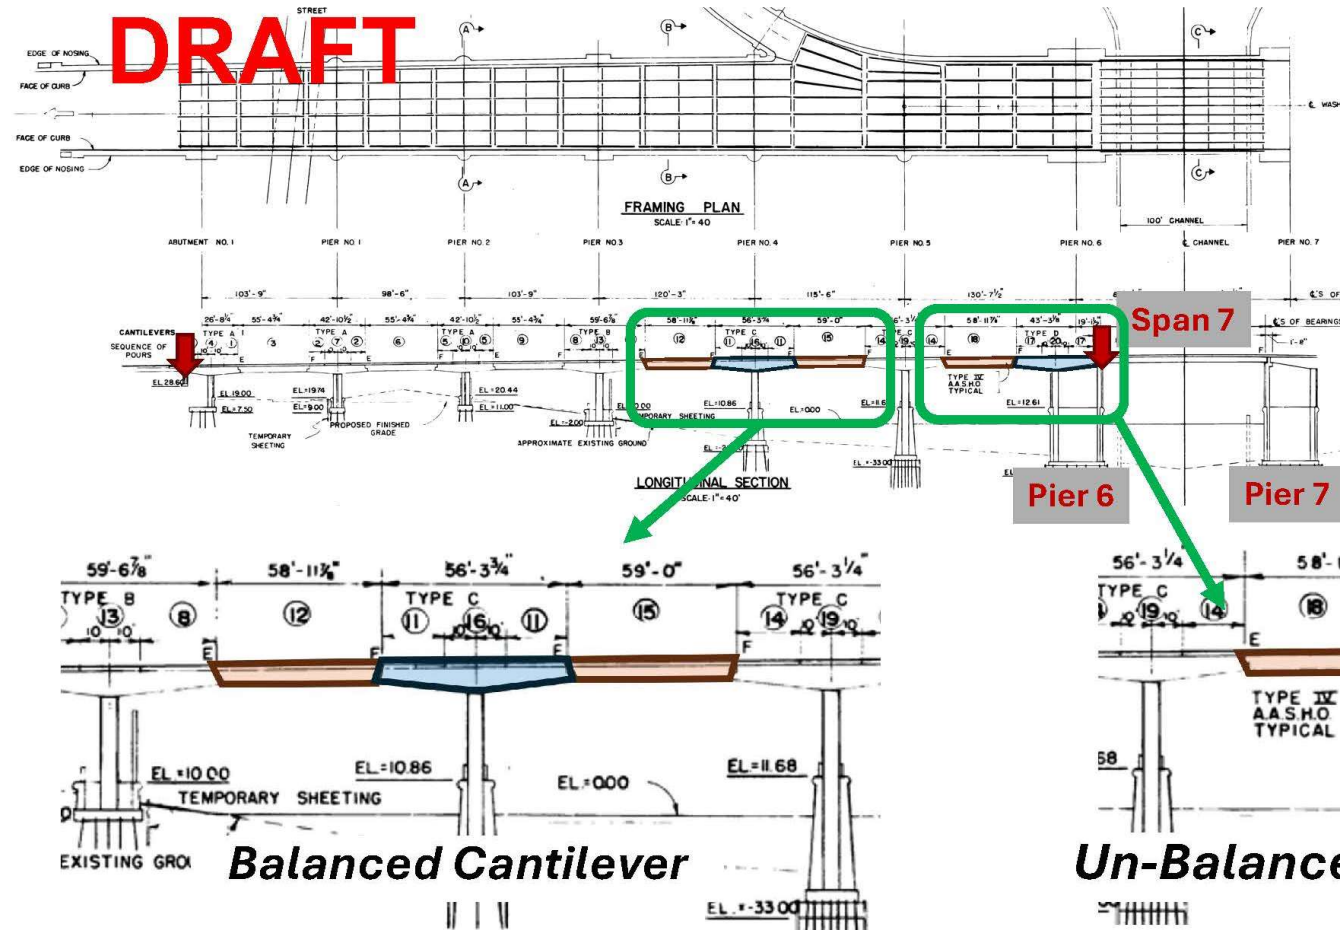
- Cantilever PT Beam
- Drop-In Beam
- Tie-Downs

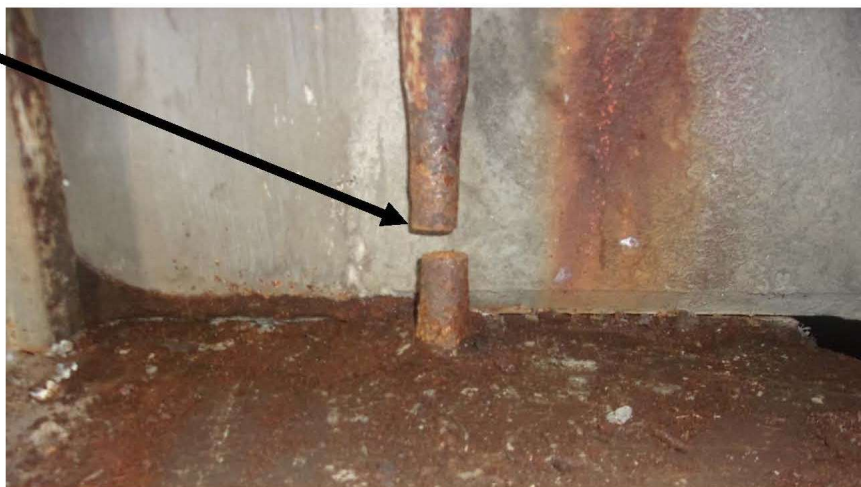
- December 8th / 11th, 2023
 - Multiple failed tie-downs at Piers 6 and 7 supporting the Unbalanced Post-Tensioned Cantilever Concrete Beams identified
 - RIDOT Closed Bridge December 11th, 2023

Failed tie-down

Cantilever PT beam

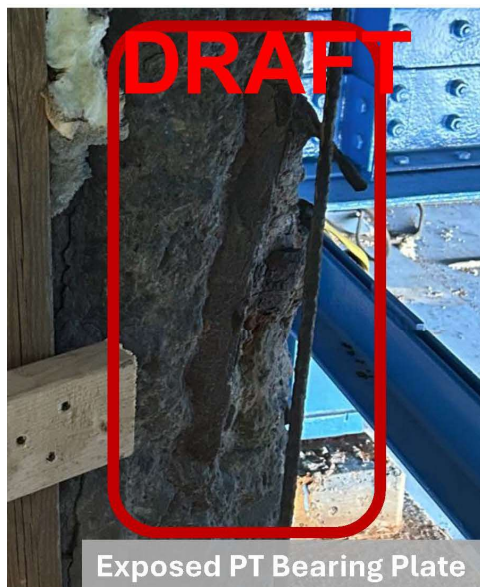
Exposed PT Bearing Plate

- January 6th – January 16th
 - Continued field investigation during repair activities identifies additional defects at cantilever PT beam ends requiring additional evaluation

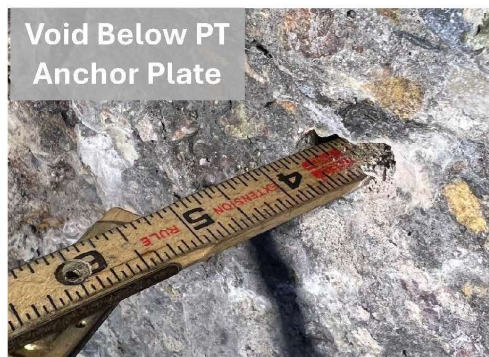
Void Below PT Anchor Plate

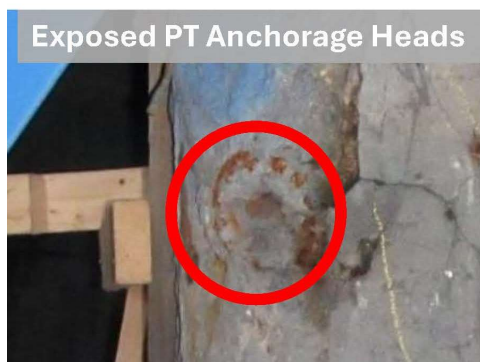
Exposed PT Anchorage Heads

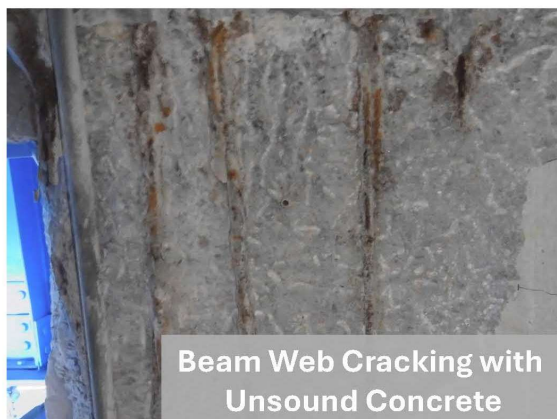
Beam Web Cracking with Unsound Concrete

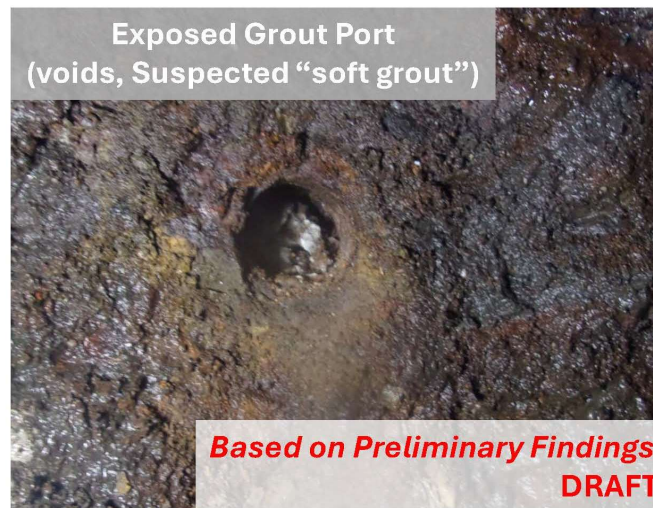
Exposed Grout Port (voids, Suspected "soft grout")

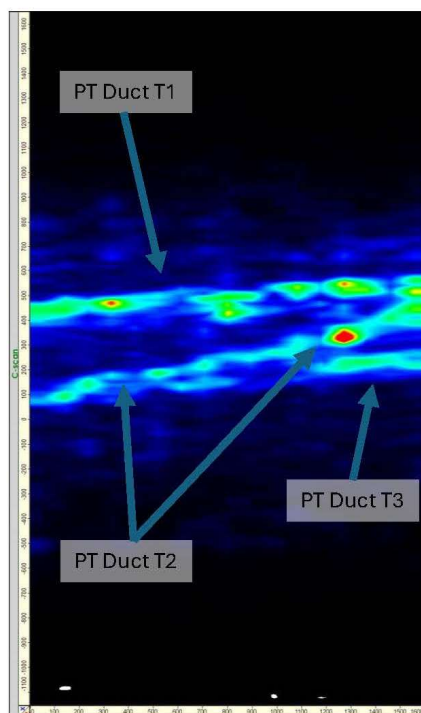
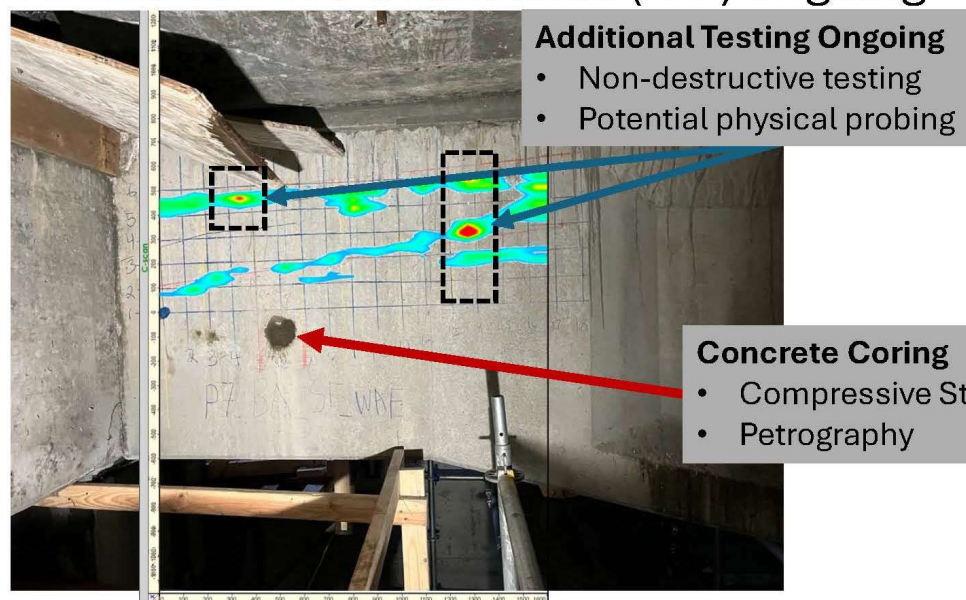
- Pier 7A, Beam A
 - Exterior beam, interior south face shown
- Evaluation of 6 beam lines (A-F) ongoing
