# THE FLOOD CREWS OF 2010

A HISTORY OF RHODE ISLAND'S 2010 FLOODS  
AS TOLD BY THE STATE'S WASTEWATER  
COLLECTION AND TREATMENT OPERATORS

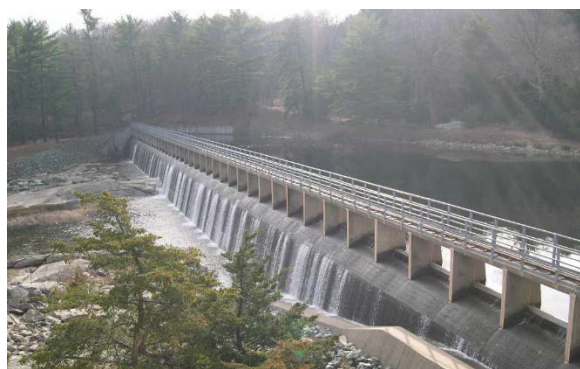
Figure 2: The Gainer Dam spillway on a normal day, with only a trickle being added to normal flows that come from the dam's central outlet, which feeds the North Branch of the Pawtuxet River. See Figure 3 for an image of the spillway's raging torrent on March 31<sup>st</sup>, 2010 (NWS/NERFC)

Flood control dams are designed differently: they essentially slow and sequester river water so that it can be released over time in a controlled manner. The Gainer Dam lacks this ability; excess water will exit the reservoir until the level behind the dam drops again.

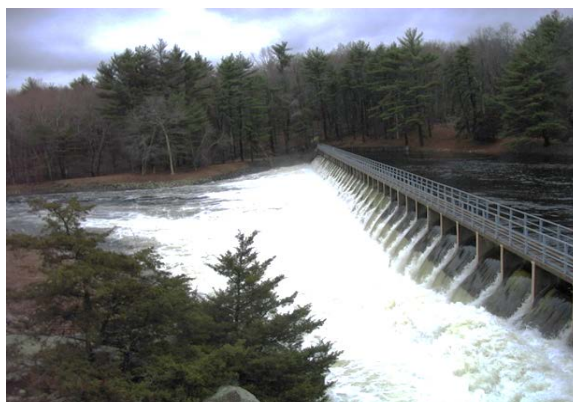
Figure 3: The Gainer Dam spillway at the Scituate Reservoir at 10:30 a.m., March 31st, 2010. Flow was an unprecedented 2.5 feet over the flashboards at a pool elevation of 287.80 feet. See Figure 3 for the spillway on a normal day, with only a trickle flowing over the flashboards. (David Vallee, NWS/NERFC)

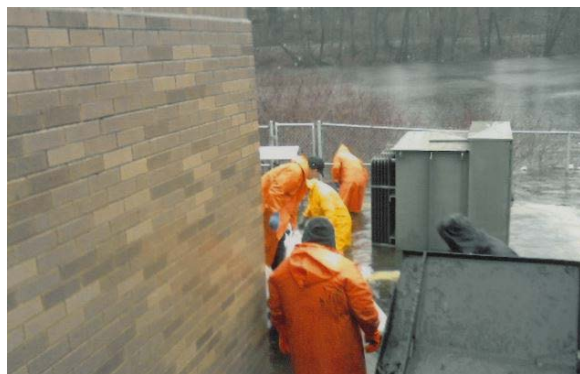
Figure 5: Crews at West Warwick make a final attempt to sandbag equipment before evacuating. (Marc Levesque)

By mid-morning, facility staff were already in full swing stacking sandbags around buildings and trying to move equipment out of harm’s way. “And as we were doing that,” recalls Lavallee, “it seemed like no time at all— maybe like an hour, hour and a half—we had to stop because no matter how high we kept putting the sandbags, it just kept overflowing the wall.” He and several other operators had been building a sandbag wall around the electrical box where power comes into the plant, but the river was rising faster than the sandbags could be stacked. Generators kicked in after main power was lost, but soon those too were submerged. “Just before we left the plant, we were in the [administration] building and the payload operator was moving us in and out of the building because the water was so high,” says Chief Operator James

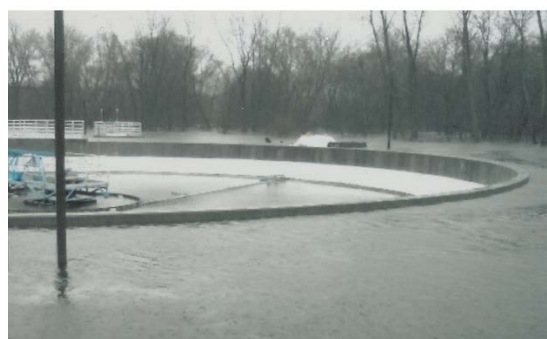
Figure 6: The Pawtuxet River rises towards the five-foot flood protection walls of West Warwick’s secondary clarifiers on Tuesday, March 30th as plant staff evacuate. (West Warwick)

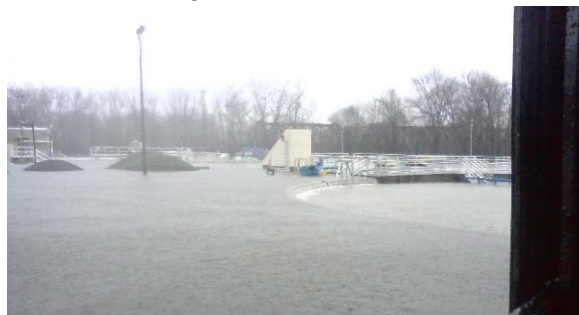
Figure 7: West Warwick's five-foot high secondary clarifiers are overtopped by the rising Pawtuxet on Tuesday afternoon, March 30th. (West Warwick)

While the flood waters caused no structural damages to the facility’s tanks or buildings, anything electrical and everything that was not metal or concrete was ruined. It was at least two days before the river had subsided to the point where staff could begin to access the facility. West Warwick’s treatment process relies on ultraviolet light for final disinfection, but the facility was without power. Operators quickly set up temporary chlorination as a substitute.

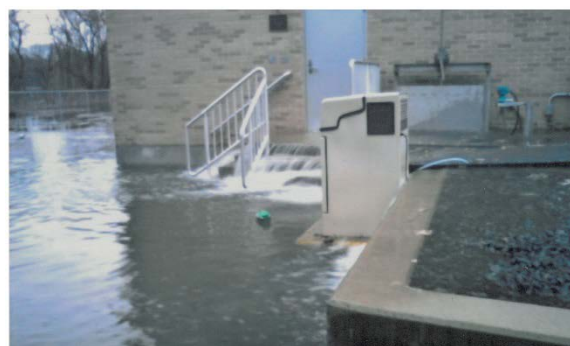
Figure 8: At higher ground, water from the flooded town makes its way into West Warwick's mostly submerged treatment facility, and out the doors of its headworks building. (West Warwick)

About 20 MGD was flowing in to the plant at the time—four times the facility’s normal rate—and a lot of unwanted material with it. Debris is normally collected and removed from the incoming flow by automated bar racks at the headworks. This system went offline as well, and the incoming flow backed up on clogged debris as it tried to enter the plant. “We were afraid to open the doors to the headworks [building],” says Lavallee. “[Water] was just pouring out underneath the doors.”

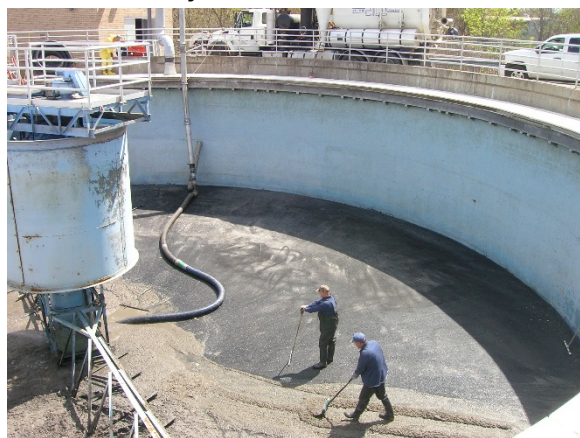
Figure 9: West Warwick staff manually pushing sludge to the center of idled primary clarifiers. From there, the sludge would be pumped away in tanker trucks. (RIDEM)

the clarifiers and the solids to settle out. Still needed was electricity to power the large boom arms that sweep the solids into troughs for collection and removal. These were back online in two weeks. In the meantime, portable pumping systems were brought in to remove the solids as they continued to enter the facility. Getting the sludge to the center of the tanks, however, had to be done the old-fashioned way—with manual labor.

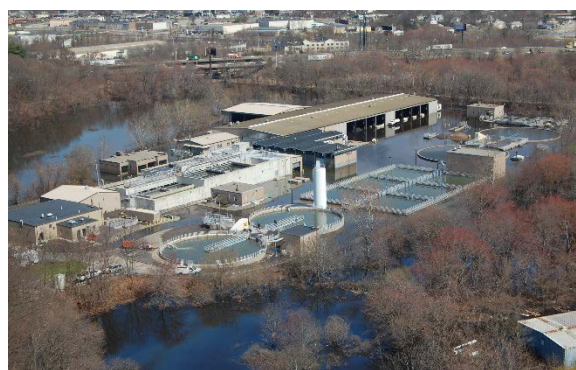
Figure 10: West Warwick two days after the crest of the Pawtuxet. (State of Rhode Island)

“Probably the good first week was cleaning,” remembers Eldridge. “Every pump room that West Warwick has was twenty feet full of wastewater. That all had to be pumped out and fully cleaned.” Brian Lavallee recalls that process: “I can remember when the water went down, walking up to the top and opening up the hatch to look into the [approximately twenty-foot deep] pump room, and the water was flush to the top of the hatch. We just looked and said ‘Oh, this is going to be fun!’”

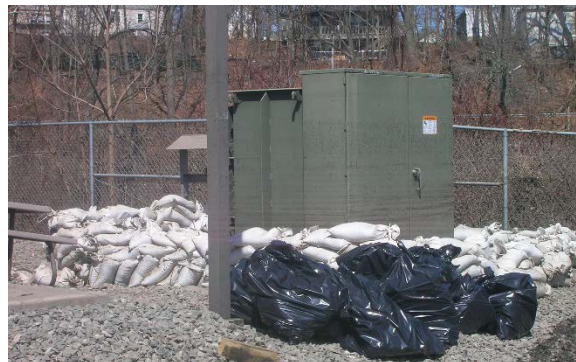
**Figure 11:** With flood waters long gone came remnants of frenzied attempts to sandbag critical components at the West Warwick Regional Wastewater Treatment Facility. (RIDEM)

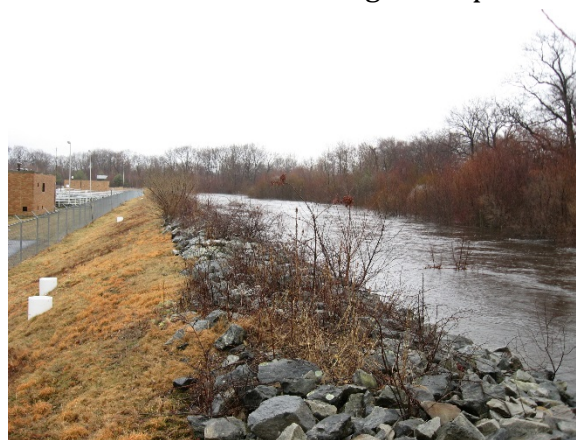
Figure 12: At 14.7 feet, the Pawtuxet threatens but does not overwhelm the 18-foot levee at the Warwick wastewater facility on March 15th. (WSA)

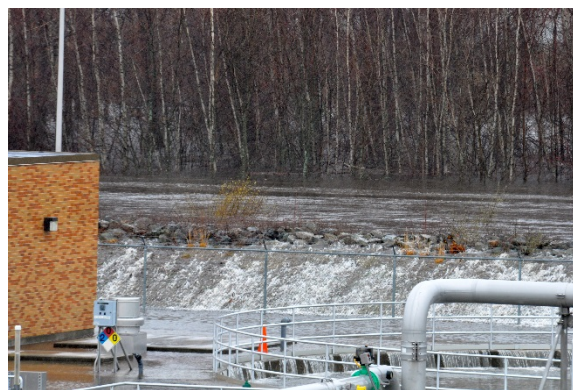
Figure 13: Warwick's 18-foot levee overtopped, bringing water into the plant and flooding process tanks and buildings soon after. (WSA)

The west side of the berm was overtopped at about 1:15 p.m. As the water poured over, it became trapped and began to fill the facility like a giant swimming pool. There was nothing that could be done to stop it. Just one half-hour later and with no alternative, the National Guard ordered the facility to be evacuated. Some vehicles and heavy equipment had already been moved to a nearby overpass, above the reach of the river. Additional office equipment was quickly stashed on the second floor of the WSA’s operations building. Staff also managed to grab some of the remaining computers and documents before they left for safety. Joel Burke recalls that those final hours just before and after the levee was overtopped were the most exhausting of the day, both mentally and physically: “I was at a complete loss for words as the city’s Director of Emergency Management watched me shut the front gates to a flooded facility.” The Pawtuxet River would continue to rise and crest the next day, March 31<sup>st</sup>, at 20.79 feet; more than double its flood stage elevation.

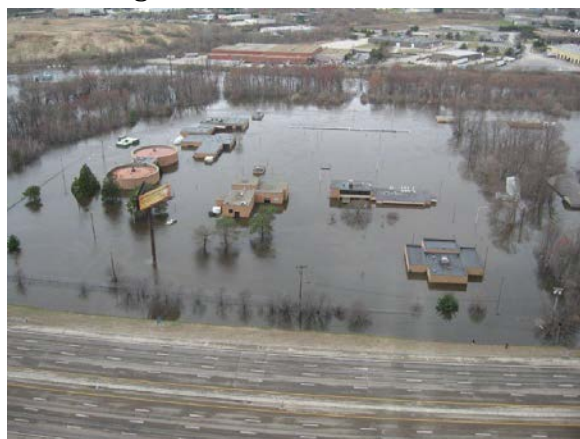
Figure 14: The flooded Warwick wastewater facility sits between the surging Pawtuxet and the closed Interstate 95 on Wednesday, March 31st. (State of Rhode Island)

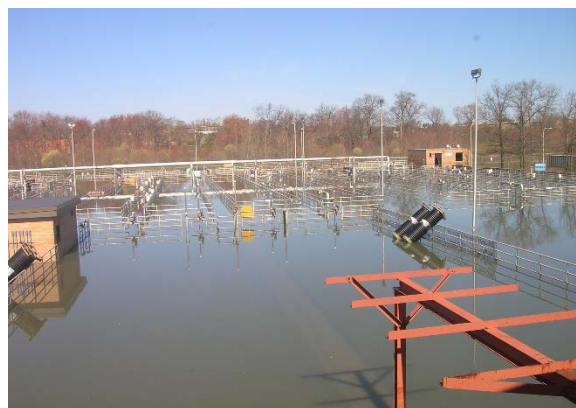
Figure 16: Warwick's wastewater facility on Saturday, April 3rd as flood water continued to be pumped back over the berm. (RIDEM)

There is an ongoing effort being made at the WSA to mitigate the damage future floods might bring. Several pump stations have been elevated or hardened against flooding. The levee that surrounds the WSA is currently being raised from the 100-year-flood elevation to the 500-year. It is an expensive and time-consuming task, but short of moving the entire plant, it's the best option. Sandbags, which were used without benefit around individual units and at building entrances in West Warwick, wouldn't have worked at the WSA either, according to Pat Doyle. "The levee is 2200 feet long. It would've taken an army of guys to build that up five feet high. It wouldn't have worked." It is important to note that the levee was not breached; it was overtopped, meaning the height of the river exceeded that of the levee. Once this happens, sandbagging individual buildings or equipment within the plant is useless; the water will rise inside the levee to meet the height of the water outside. At that point, "you're not going to stop it," Doyle concludes. "If it's coming up, it's coming up."

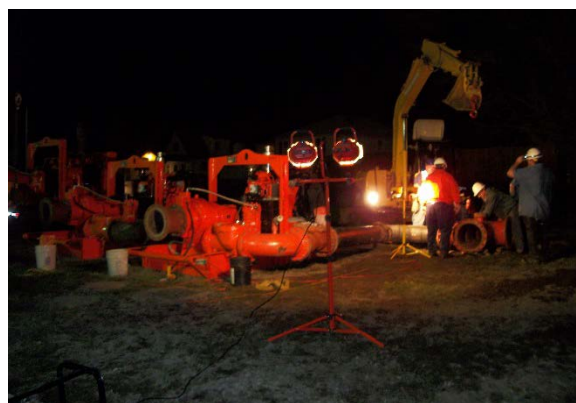
**Figure 20: Bypass pumping being assembled at the Pontiac Avenue Pumping Station. (Veolia Water)**

segments of heavy piping into place and then making the connections. Assistant Maintenance Supervisor Randy Sposato was forced to improvise several times during the process. First, he hired a tracked excavator to come and maneuver the giant pumps into position around the backside of the pump station instead of using a crane to lift the pumps up and over as they had done in the past. This ended up saving considerable time.

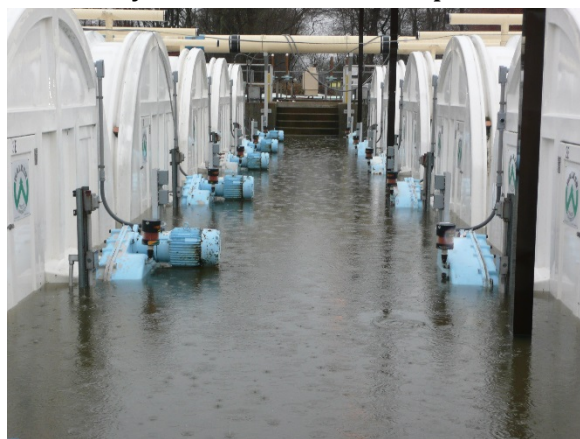
**Figure 21: Bristol's Rotating Biological Contactors going under water as local flooding throughout the town makes its way to the treatment plant on March 30th, 2010. (Bristol)**

(RBCs). This system is comprised of large mesh drums that sit partially in wastewater and slowly rotate to grow a layer of bacteria that consume waste. The drums and the motors that turn them were submerged as the water backed up. The motors did turn back on and kept working after the flood, but later began to fail one by one and had to be replaced.

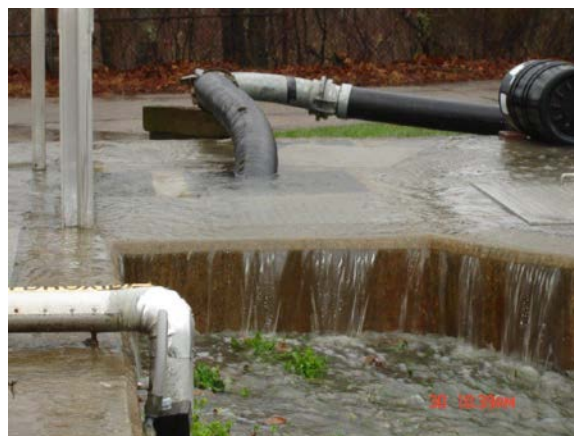
Figure 22: Heavy flows arriving at the Westerly wastewater treatment plant from townwide flooding upstream overwhelmed the plant's influent structures. Crews here have installed temporary pumping to help relieve the flow and keep it in the system. (Westerly)

The treatment plant is high enough on the river bank that it was not flooded by the Pawcatuck directly, but the massive flow of wastewater coming through the town's collection system was causing other problems. By Tuesday morning, the plant's headworks and primary clarifiers were overflowing uncontrollably, and the water ran down around the operations building and began to pool in a garage on the first floor. "[T]he water was probably eight or nine feet-deep in that garage," says Westerly Chief Operator Tim Costa. "And the sump pump that's in there, that also pumps it back into the system, just couldn't keep up with it."

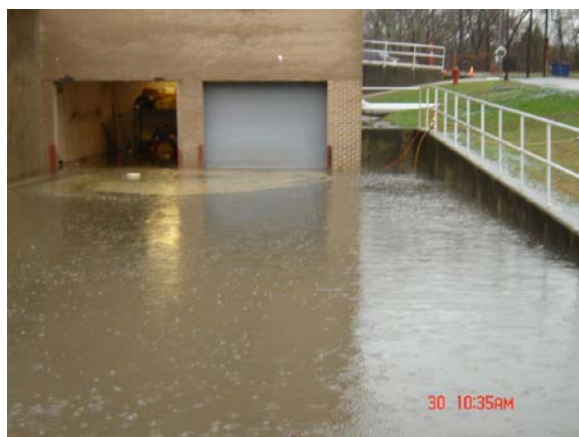
**Figure 23: Westerly's lower garage filling with overflow from the overwhelmed plant uphill on March 30<sup>th</sup>, 2010. Eight feet of water eventually found its way to this low spot. (Westerly)**
