**RHODE ISLAND DEPARTMENT OF TRANSPORTATION  
BRIDGE ENGINEERING-BRIDGE INSPECTION UNIT**

**BRIDGE CRITICAL FINDINGS  
(Form BI-006)**

<b>Bridge No.:</b>	070001
<b>Bridge Name:</b>	Washington Bridge North
<b>Route Carried:</b>	I-195 WB
<b>Crossing:</b>	Seekonk River
<b>City/Town:</b>	East Providence

**Date Reported:**  
12/11/2023  
**Time Reported:**  
11:30  
**Reported By:**  
Jeff Klein  
**Firm/Agency:**  
VHB

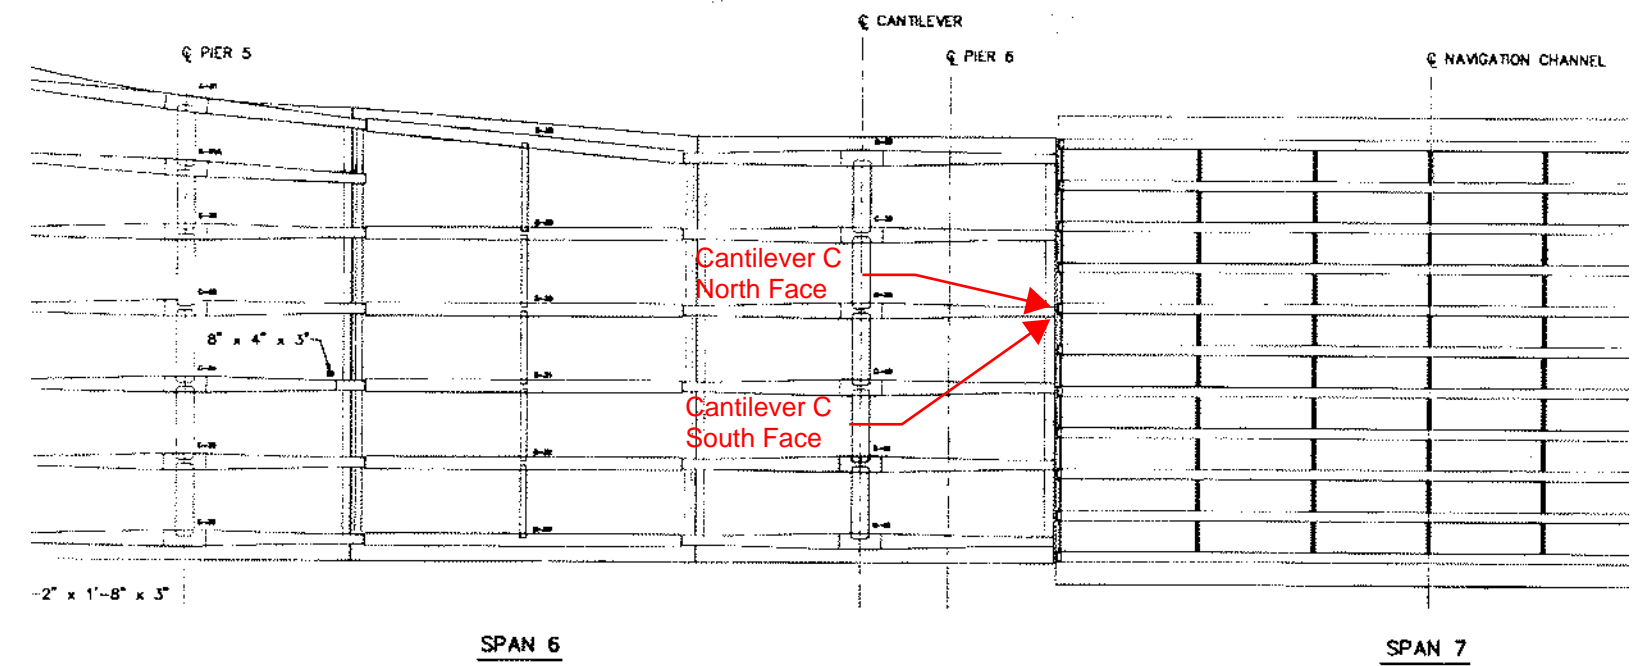
Cantilever C North Face

- Spalls on diaphragm at Cantilever C north and south face. Rust stain on the Bay B diaphragm at approximate tie down steel rod location, and exposed steel rod at Bay diaphragm.
