## **Forensic Investigation of Failed Post-Tensioned Tie-Down Rods I-195 SB Washington Bridge North (700)**

**Evaluation of I-195 Washington Bridge PT Bar Fractures**  
 WJE No. 2023.7858.0

**Metallurgical Evaluation**

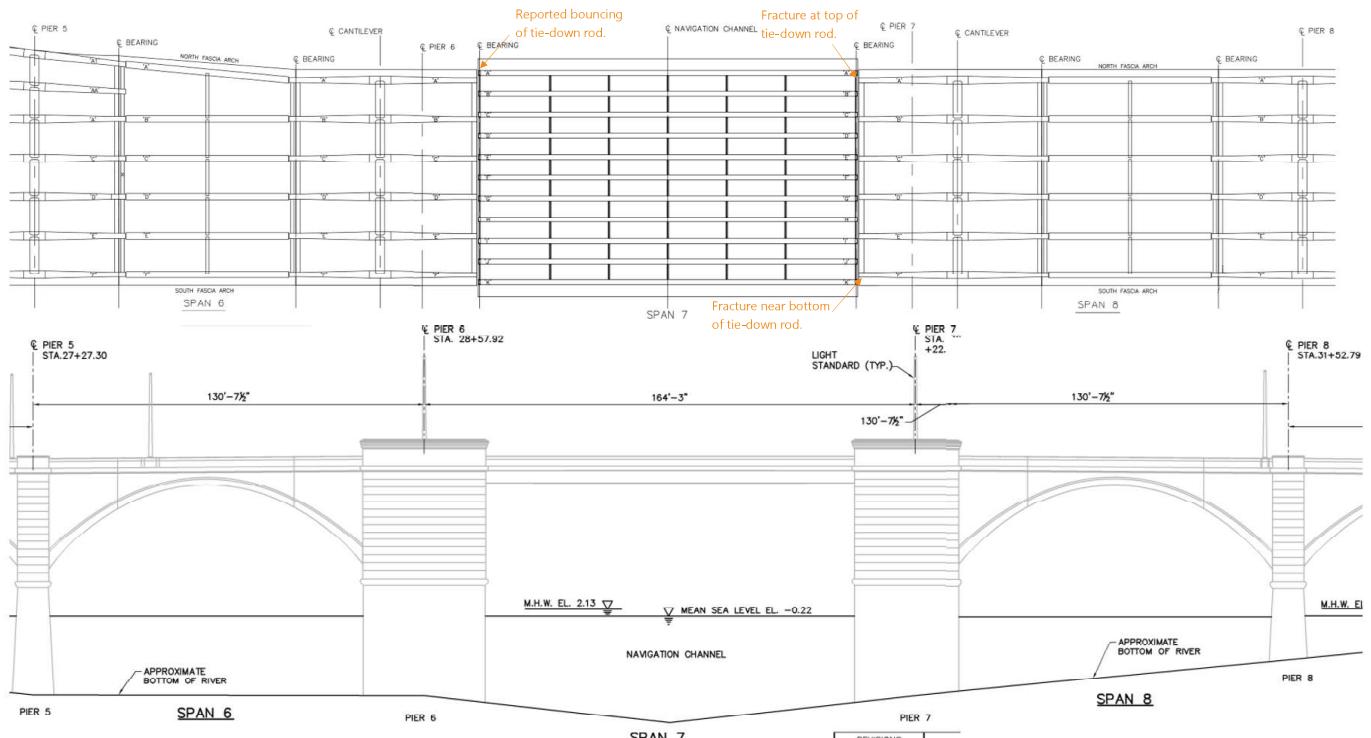
The approach structures comprise post-tensioned concrete balanced cantilever beams on concrete piers that support prestressed concrete drop-in girders between them (Figure 1). The end cantilever segments are tied down with PT rods to reinforced concrete corbels on the outward structural walls of Piers 6 and 7 to either side of the steel main span, Span 7, to counterbalance the loads of the drop-in beams in Spans 6 and 8. There are six concrete girder lines (A-F), with twin tie-down rods for each. The tie-down rods are embedded in the diaphragms at ends of the cantilever beams for girder lines B-E and extend down into the corbels, making them thus not visible for inspection. However, at the four outward corners at girder lines A and F of Piers 6 and 7, the outboard tie-down rods lie to the exterior of the cantilever beam ends, where there are no diaphragms, and are exposed from the top of the beam seat to the bottom of the concrete deck.

Figure 1. Framing Plan and Elevation of Spans 6 through 8, southbound I-195 Washington Bridge North (700)

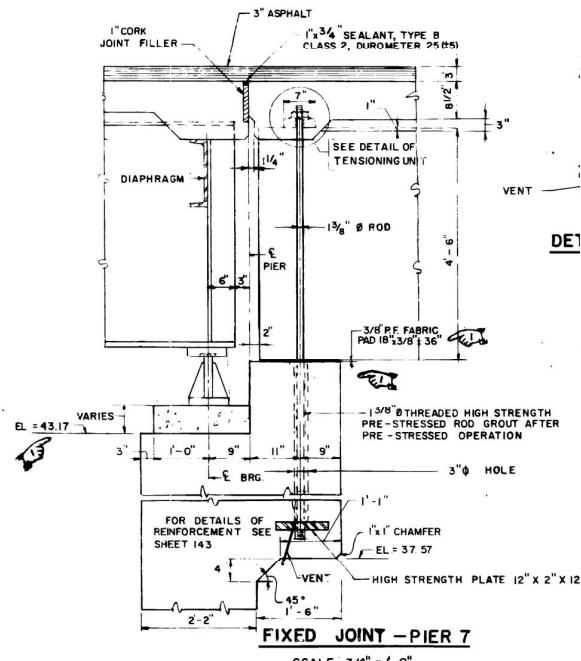
Photos of the fractured bars taken by WJE on December 16, 2023 are shown in Figures 2 and 3. The bars were corroded on the exterior perimeter and the cross-section was reduced/tapered in the regions around the fractures. According to original design drawings, the prestressing rods were to be 1 3/8" diameter threaded high strength pre-stressing rod to be tensioned to 120,000 lbs. each (Figures 4 and 5). No specification is cited for high-strength rod and original project specifications were not provided. As a basis for comparison, Table 1 shows relative stresses based on section loss and applied post-tension load only. The applicable design specification would have limited post-tension load before losses to 0.7  $f_s$ .<sup>2</sup>

Figure 4. Section A-A excerpt from Detail Sheet 4 (Sheet 139) of original design plans (1967)

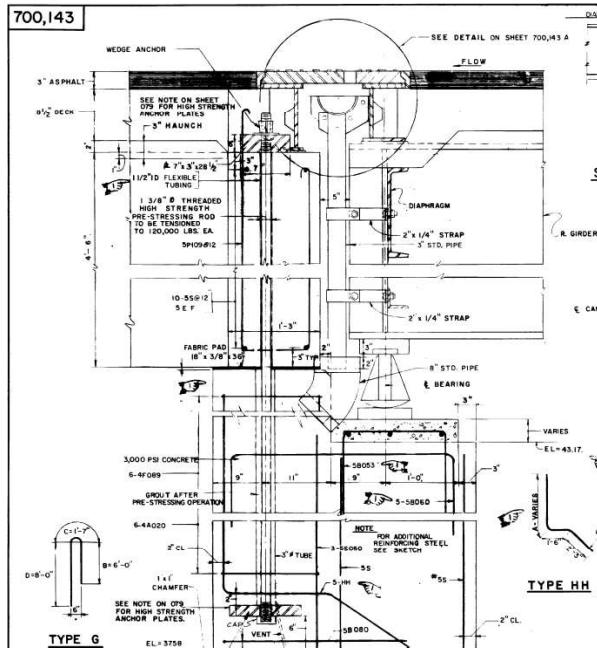
Figure 5. Section A-A excerpt from Detail Sheet 8 (Sheet 143) of original design plans (1967)
