American Rescue Plan State Fiscal Recovery Fund Recommendation Cover Sheet

Name of Lead Agency: Prudence Park Water Association

Brief Project Description (attachments should contain details)
Essential rehabilitation of the Prudence Park Water system, a small public water system

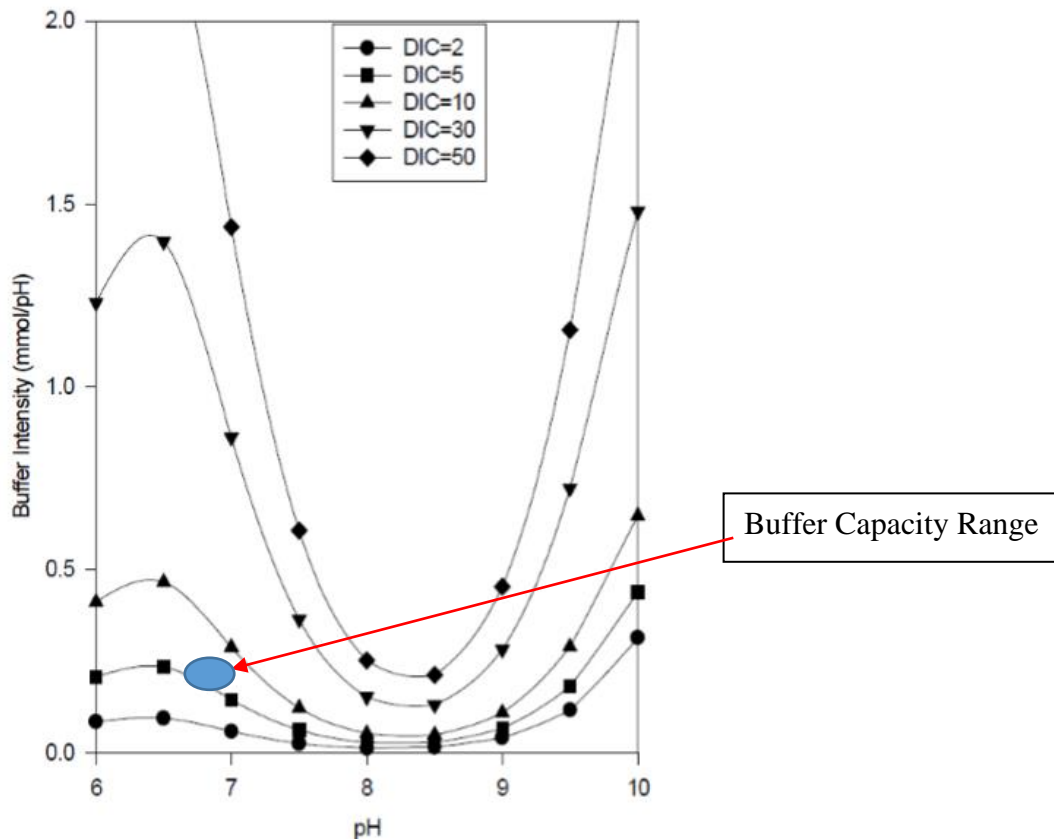
Figure 3-1: Buffer Capacity as a Function of pH & DIC (from USEPA 816-B-16-003)

The relationship of alkalinity and chloride is a significant factor in evaluating a water characterization relative to corrosion potential. Experience has demonstrated that bicarbonate alkalinity (HCO₃) concentrations of 50 – 60 mg/l (as CaCO₃) are often favorable to mitigate corrosion, however the relationship of alkalinity to chloride (and sulfate) must also be considered. As noted in Table 3-1 despite the well water containing moderately low (24 to 28 mg/l, as CaCO₃), the **alkalinity-to-chloride ratio (2.02 to 3.23) is favorable**, due to the low chloride content (8.5 to 11.9 mg/l), relative to buffering of acid formation in the water. **However, the consistently low alkalinity content does limit buffering capacity and localized areas could experience corrosion** at the thin film interface with metallic (brass, copper) components in the water supply system. It should be noted however that the buffering capacity of the water (resistance to pH change) is a function of the alkalinity, dissolved inorganic carbon (DIC) and pH. Based upon a pH range of 6.8 to 7.3 su and an alkalinity range of 24 to 28 mg/l (as CaCO₃) the DIC content in the water is low, within a range from 6.0 to 8.0 mg C/l. Figure 3-1 presents standard curves for “buffer capacity” as a function of DIC and pH. The water characterization range experienced in the Prudence Park system demonstrates low buffering

capacity, and the water is highly susceptible to local changes in pH due to corrosion chemical reactions, temperature change, and other factors.
